5:28:30 E.T.  
 10.14.22 | 1.13.22  
 1.4.21 | 8.30.22  
 8.25.21 | 1.26.23  
 File 70TH ST | 8.9.23

CELL 7001E  
 0 - 50 ft

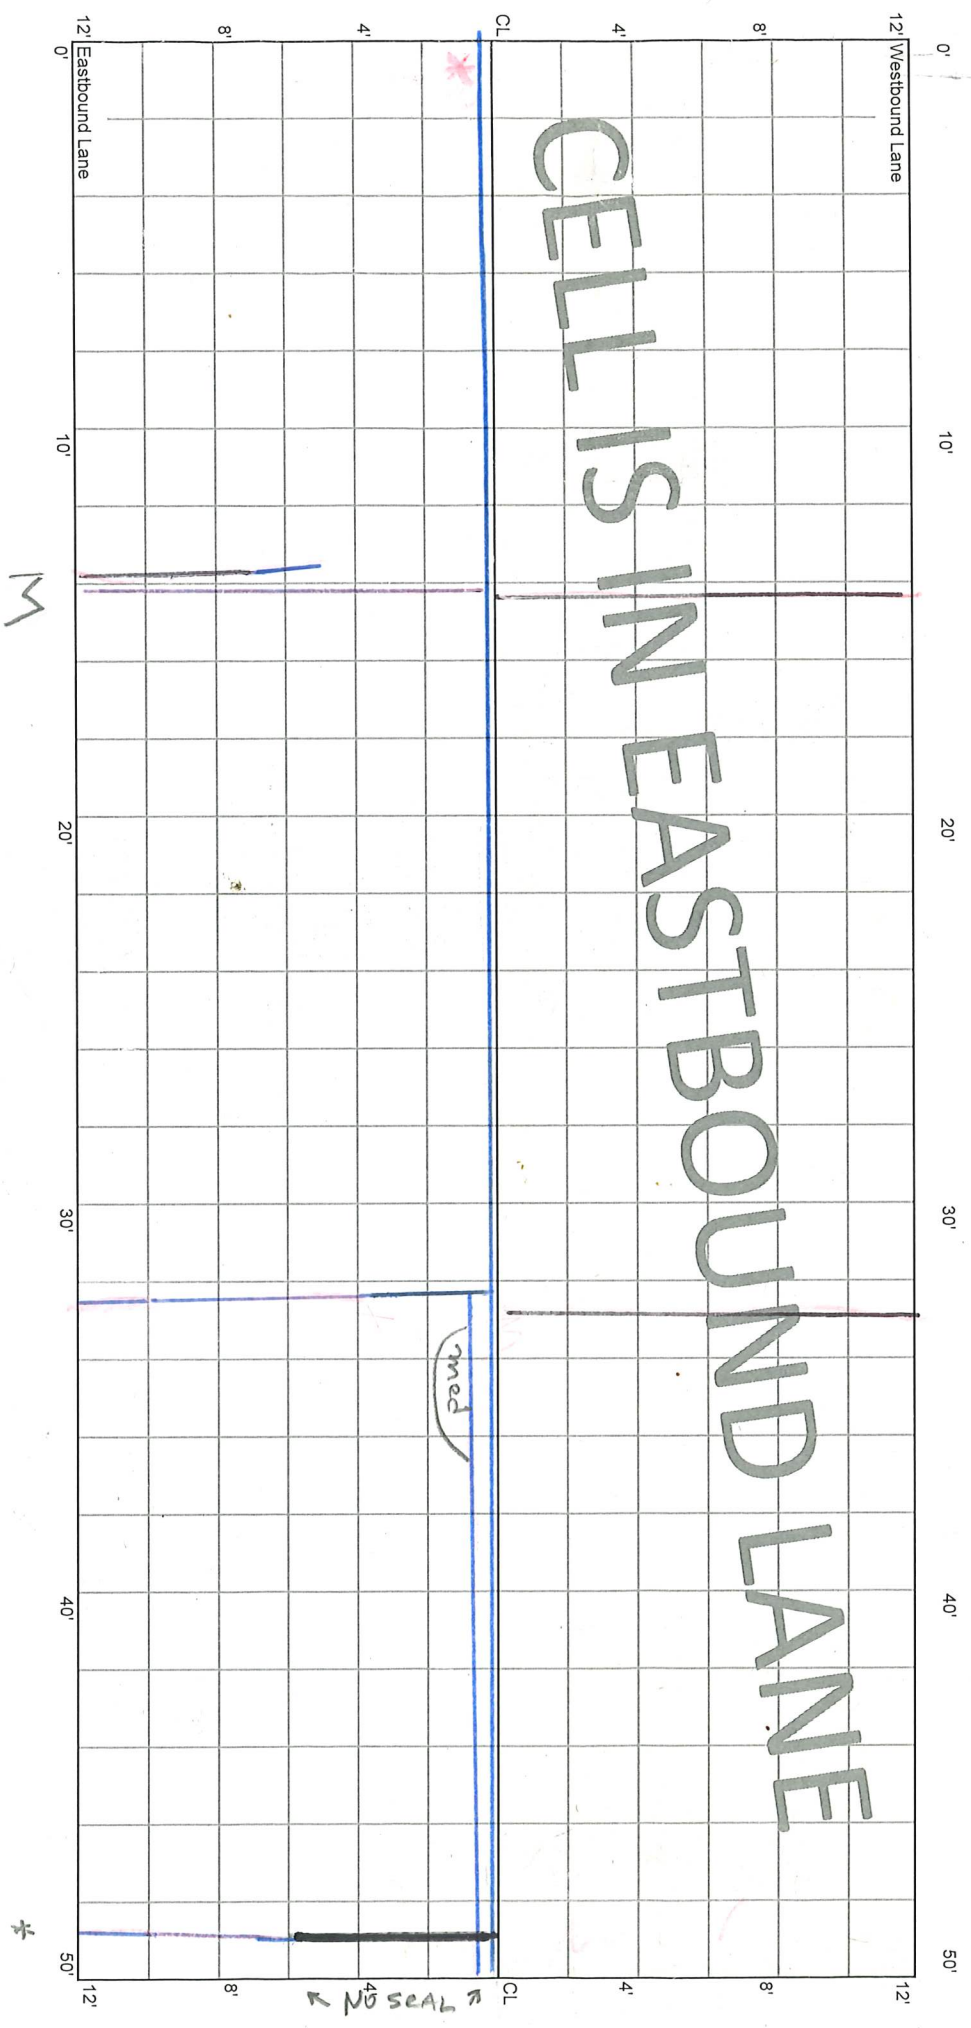
\* Rout 1 Seal  
 8/2022 - "M" Due to multiple cracks

8/22 - Sealant + debris & many stones on mat.

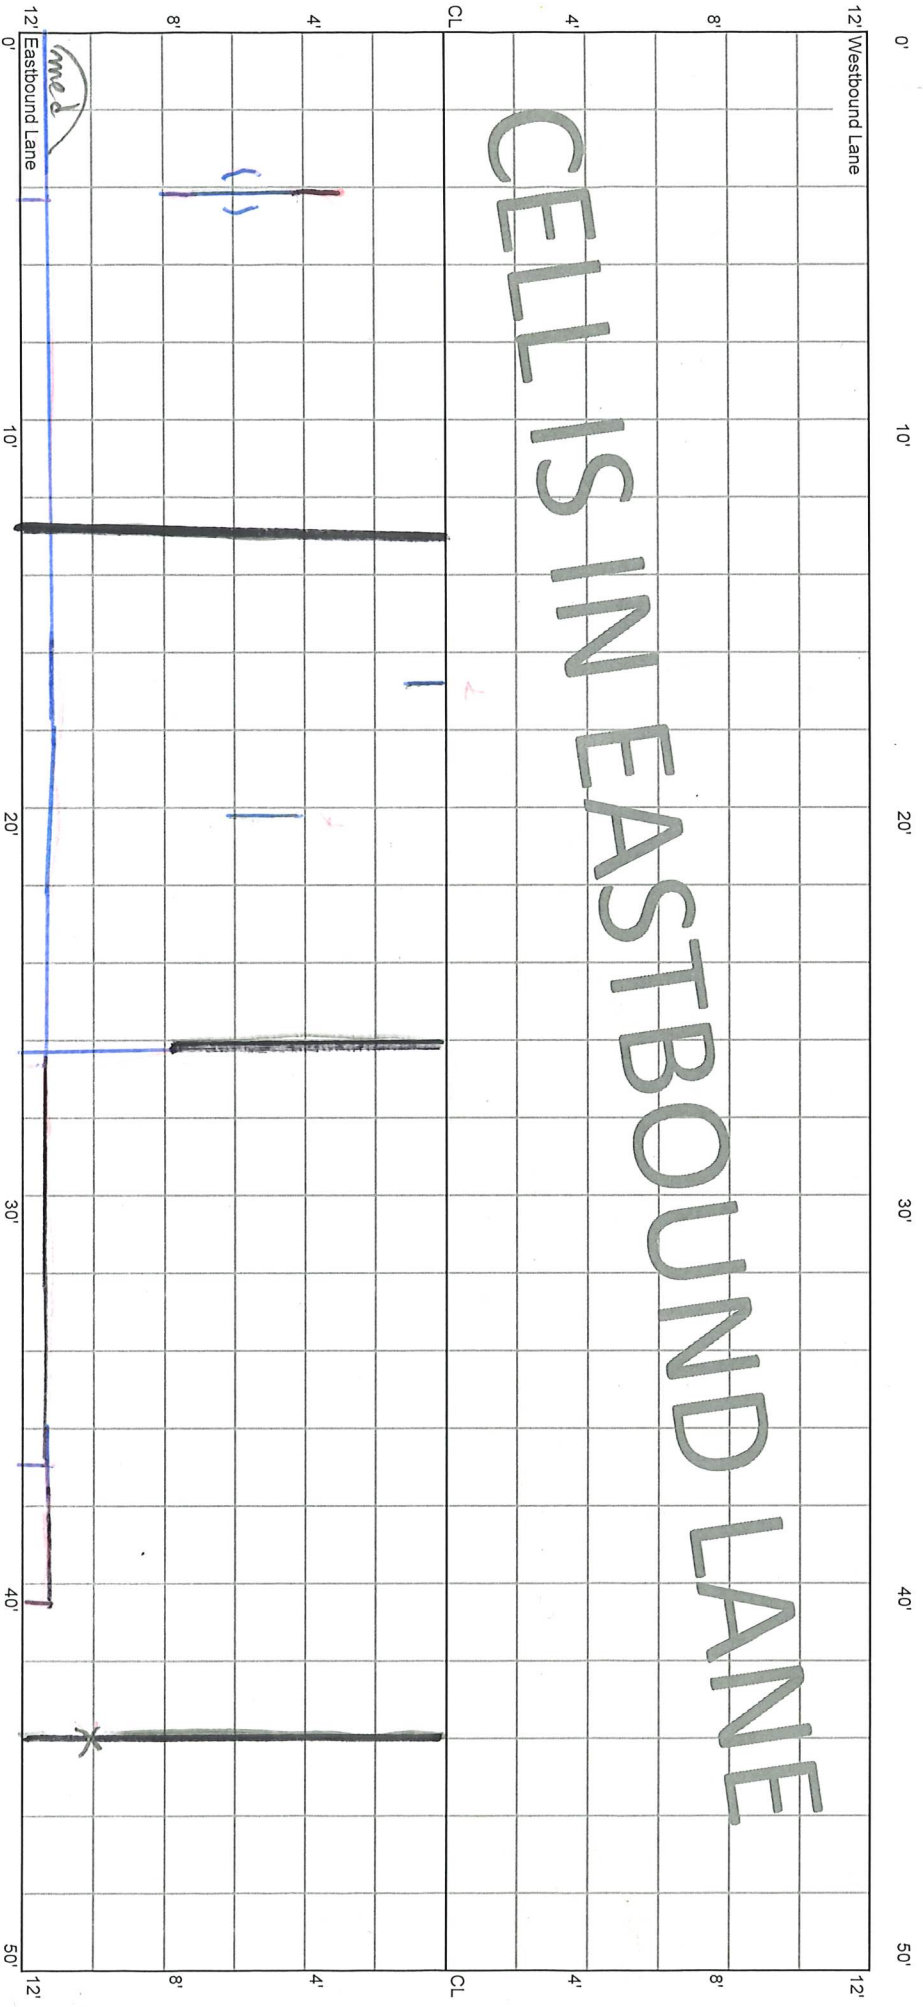
CELL 7001E  
100 - 150 ft

\*  
M  
AF, sp

\*  
M  
sp

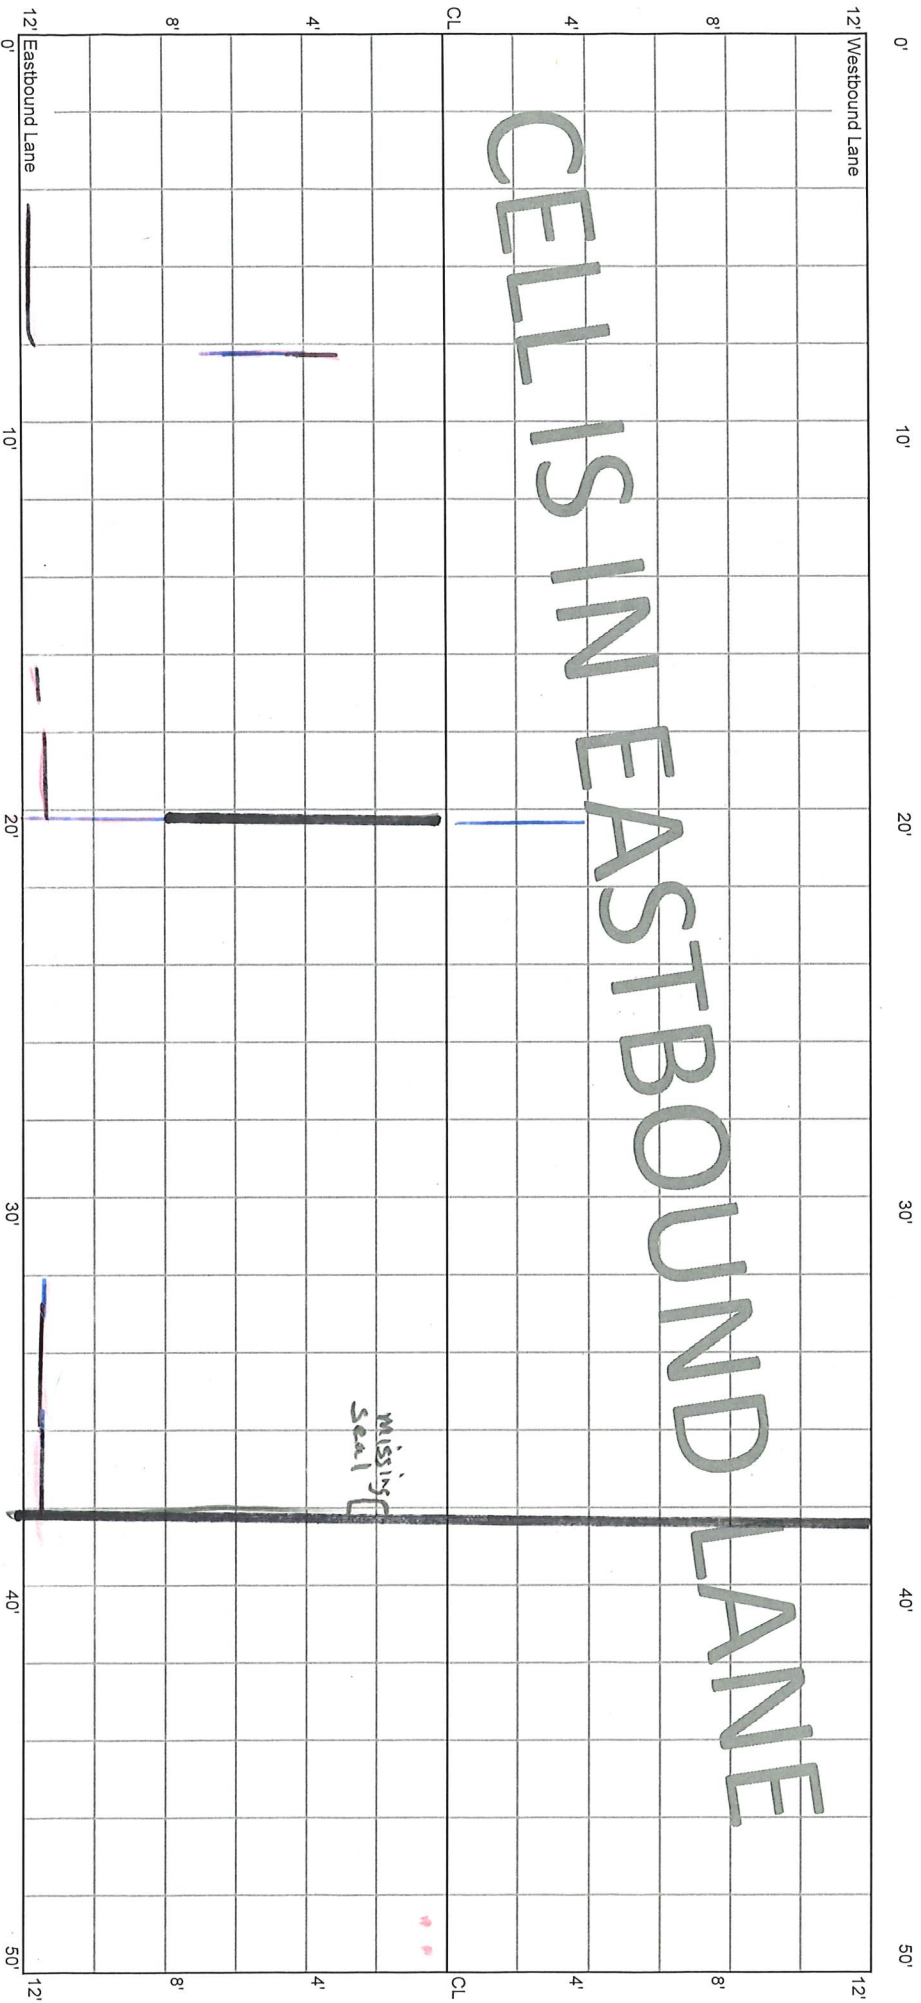
CELL 7001E  
150 - 200 ft

MISSING  
Seal

\* M

8' seal

SP

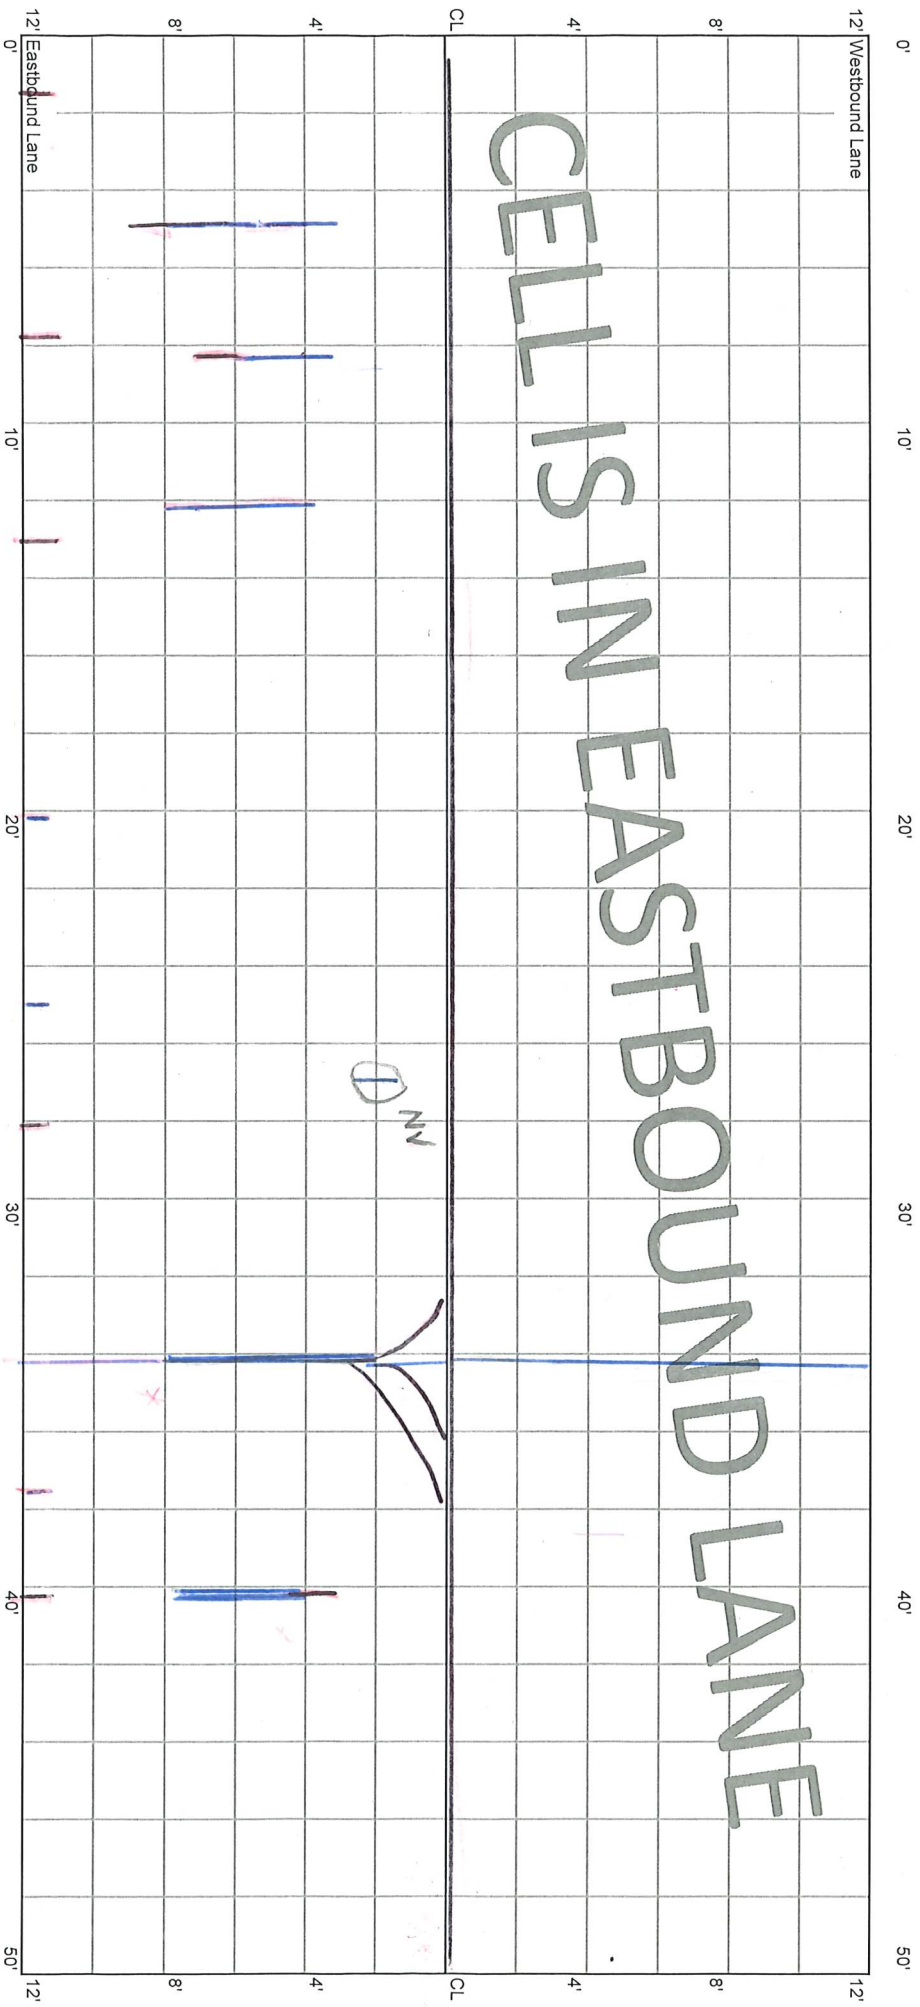
CELL 7001E  
200 - 250 ft

S  
M  
Debris

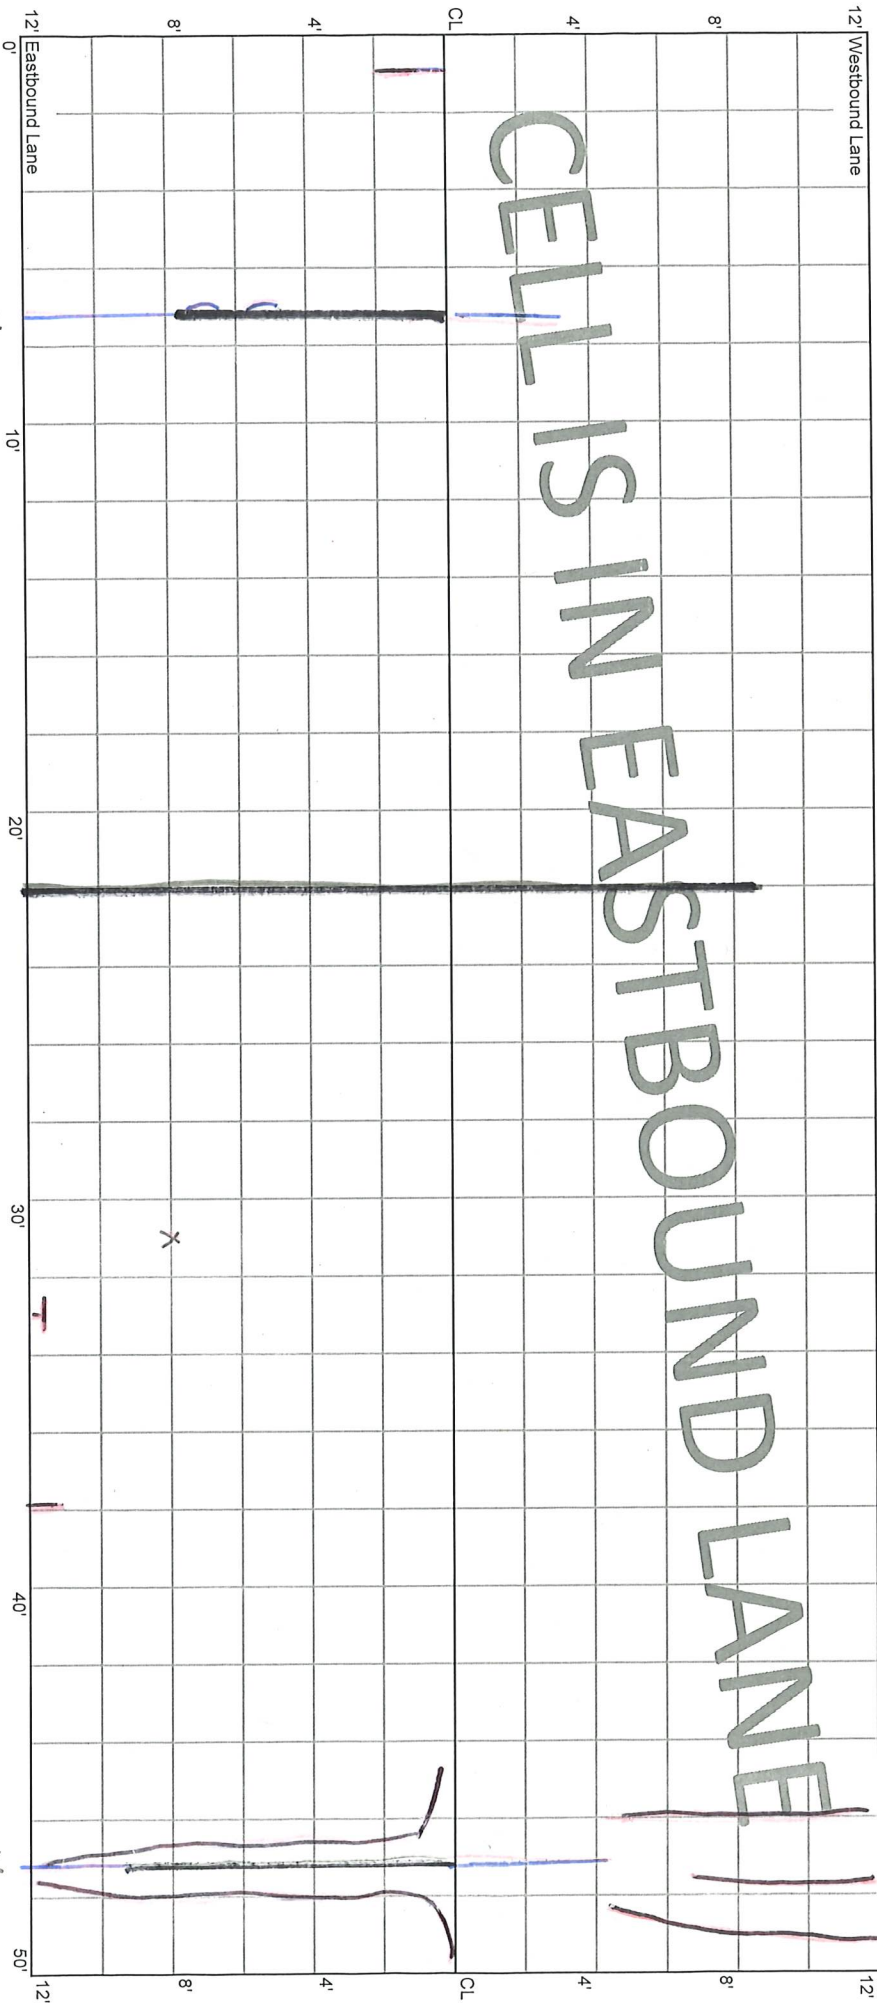
CELL 7001E  
250 - 300 ft

M  
8-in AF, SP

M

H  
SP

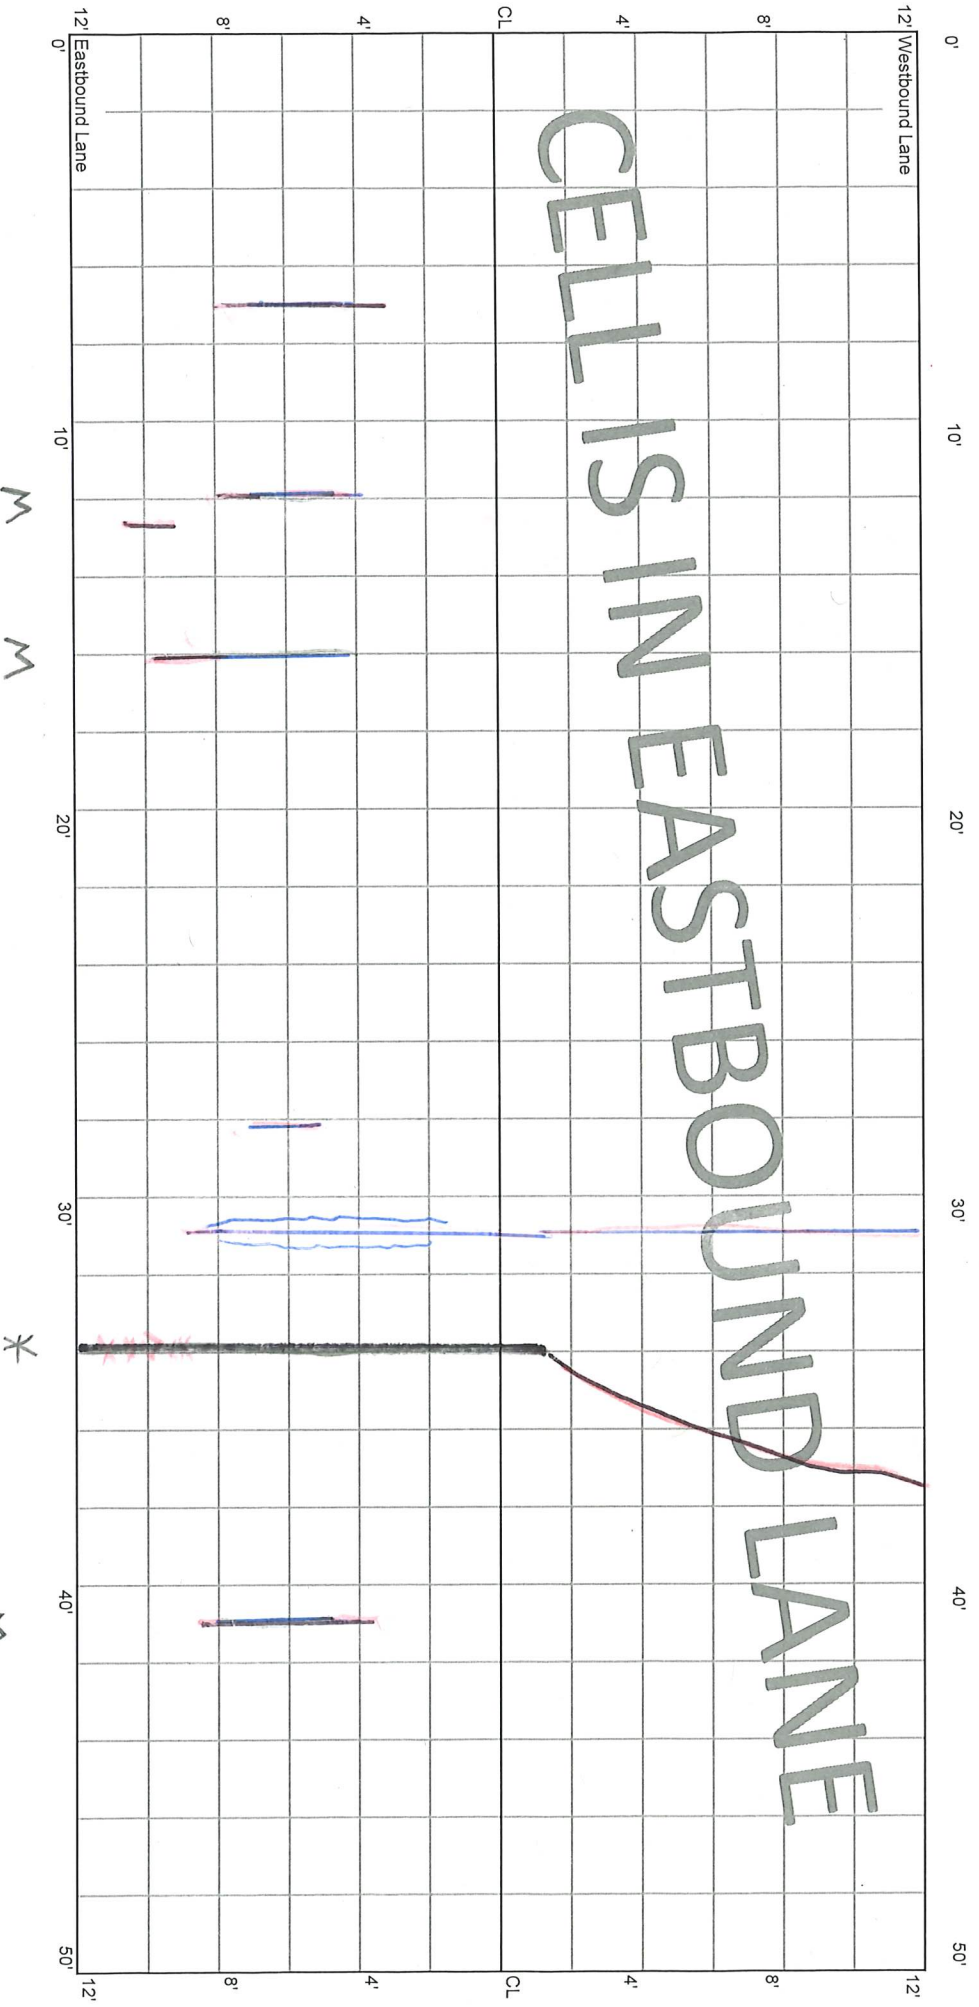
CELL 7001E  
300 - 350 ft

P 319

M  
P 319

M  
5'

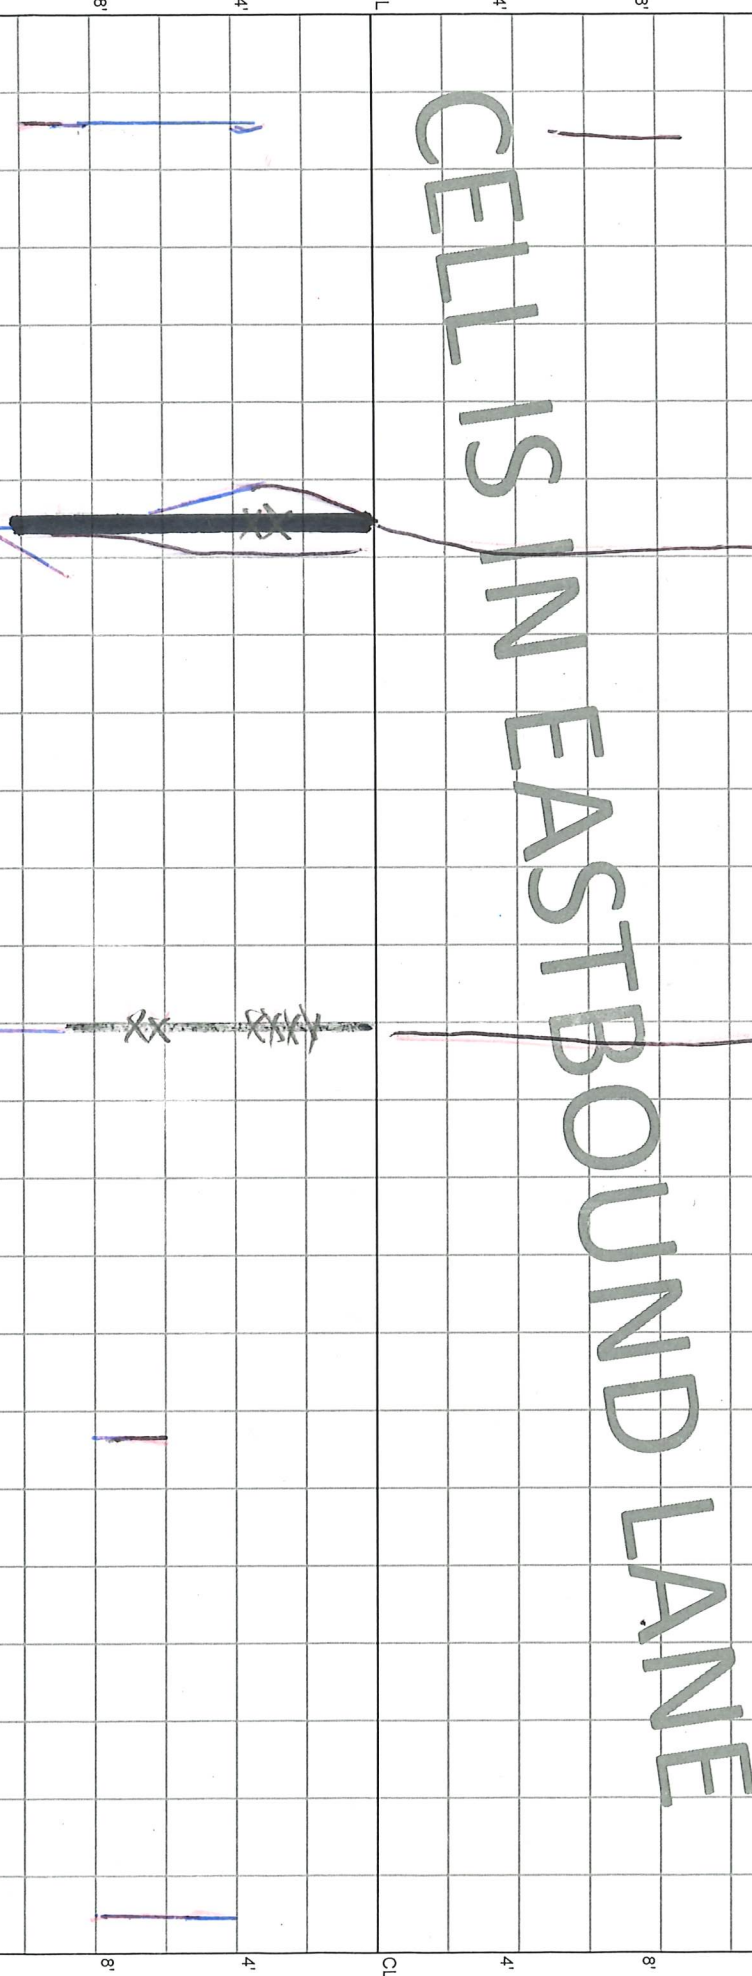
CELL 7001E  
350 - 400 ft

\* 10-ft  
SP  
M

\*  
M

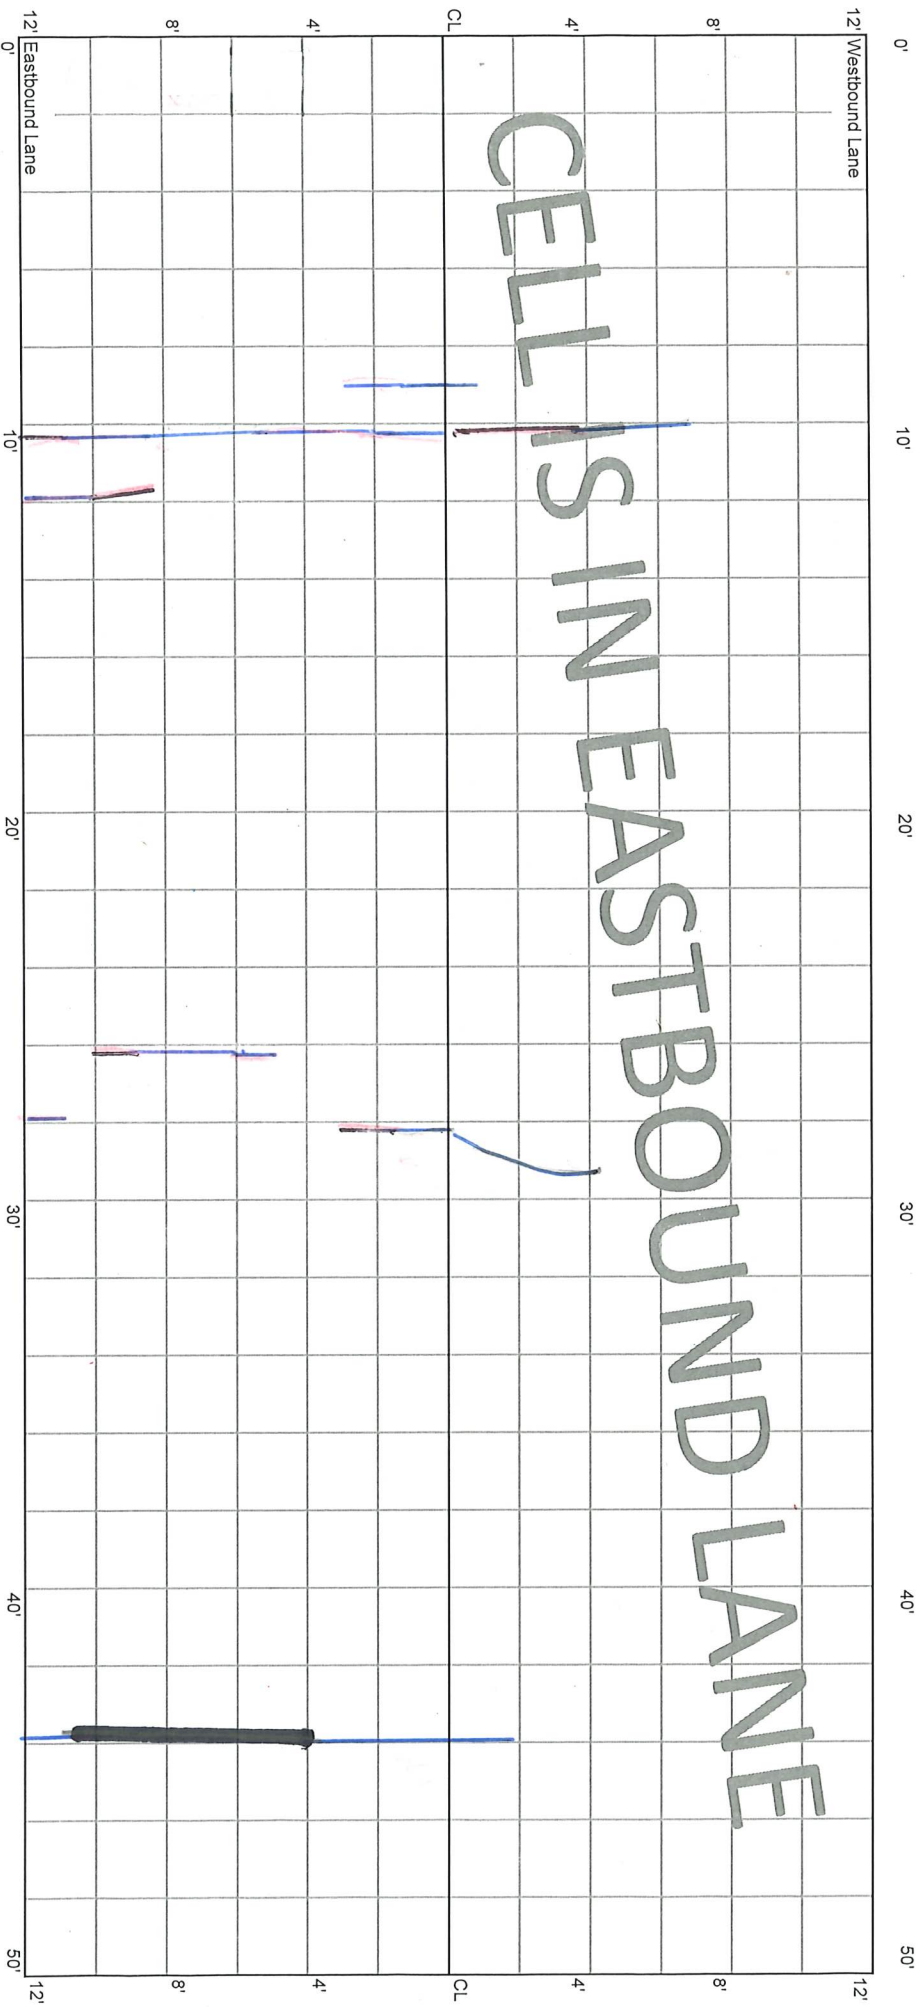
CELL 7001E  
400 - 450 ft

M

12' M  
1/2' S.P., 1/2' A.F.

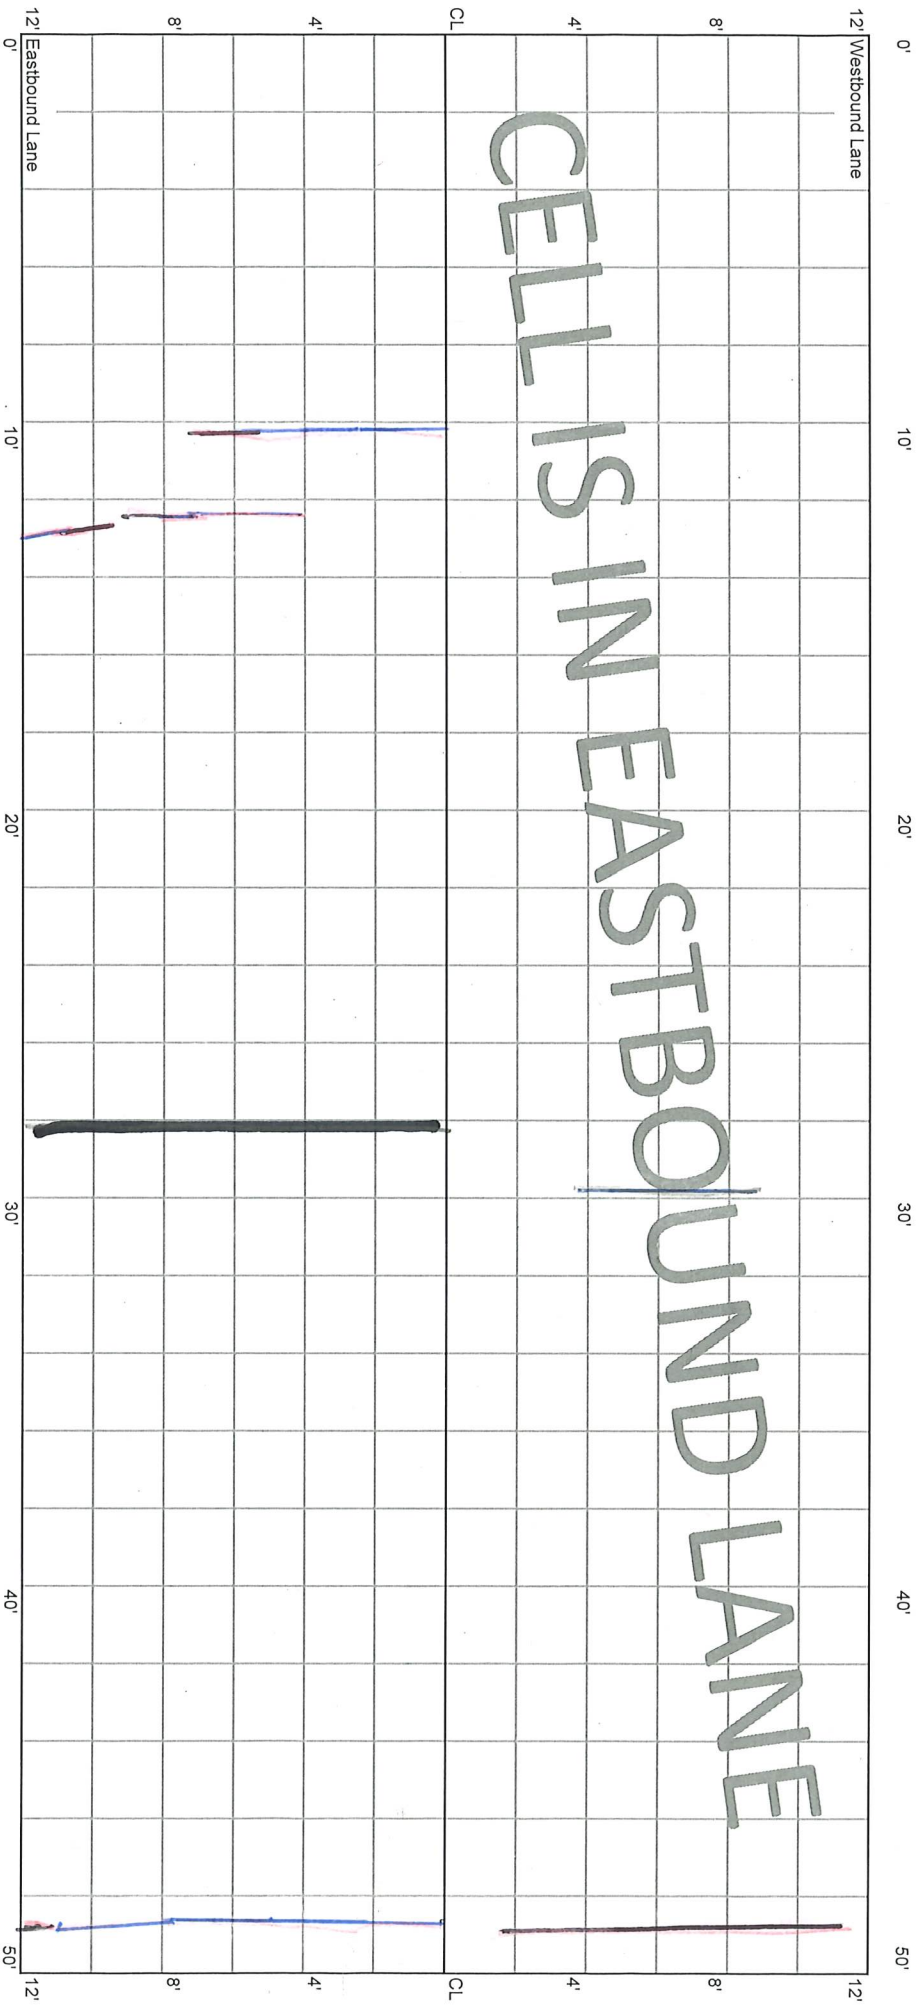
CELL 7001E  
450 - 500 ft

(AF, SP) - 2++

M
