B.25-21 - 59 sklar cracks

File 70TH ST
8.25.21 | 8.31.22
1.13.22 | 1.26.23
8.11.23

CELL 7007E
0 - 50 ft

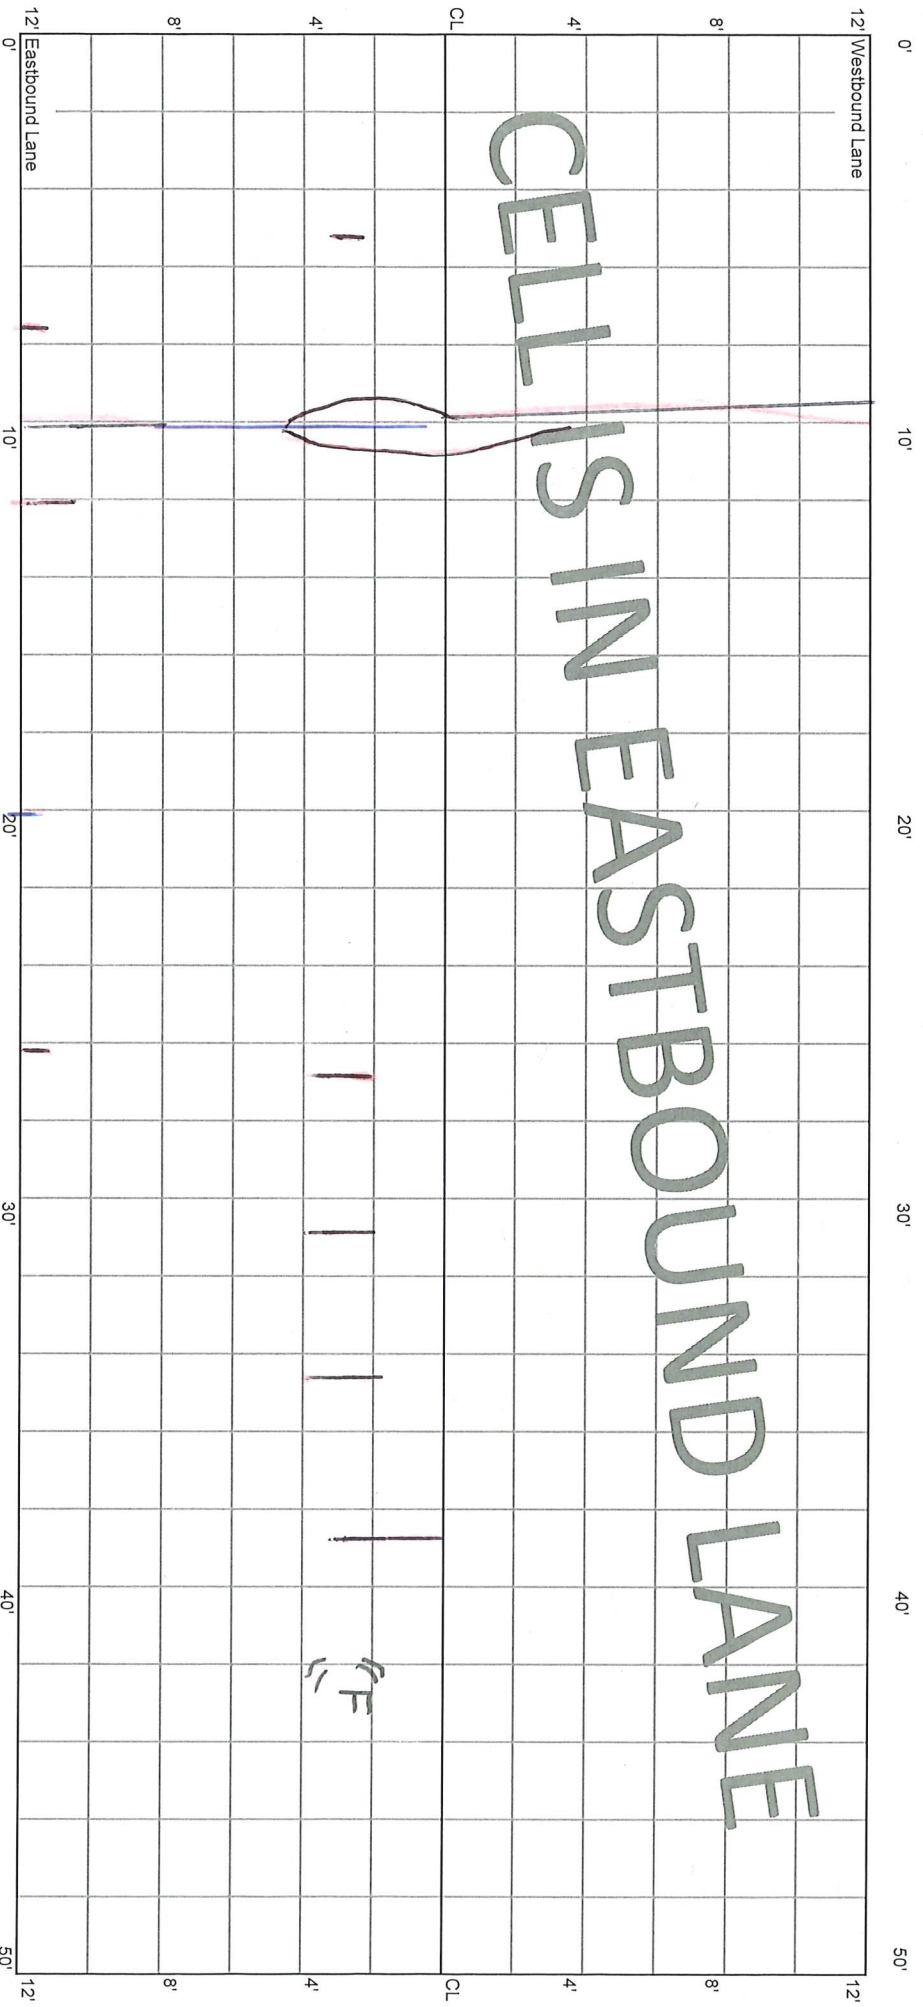
CELL 7007E
350 - 400 ft

Sliproad
Shoulder Rutting
outside F.I.L
2978 - 380
