B.25-21 - 59 shield cracks

CELL 7007E
0 - 50 ft

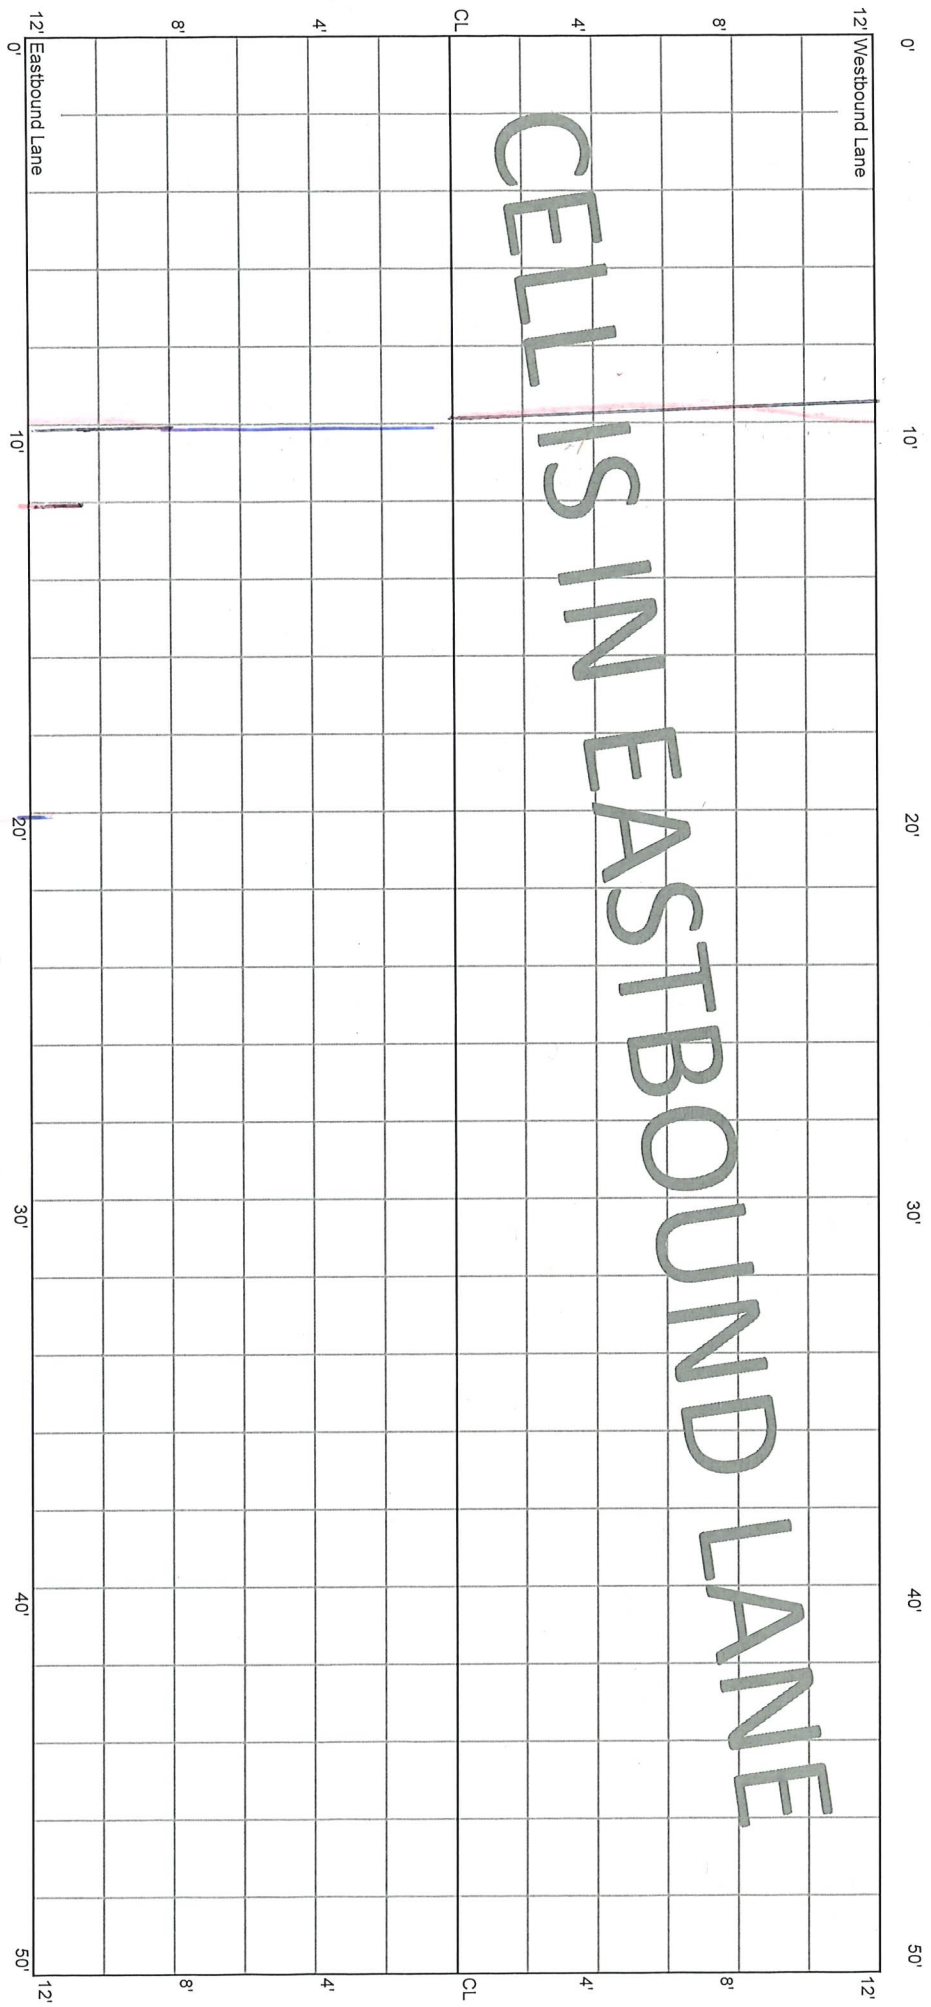
CELL 7007E
350 - 400 ft

*5/10/00
Slope Rating
S 1/4
S 1/4
S 1/4
2' x 4' - 3' x 6'*
