High Tension Cable Median Barrier: A Scanning Tour Report

By
Juan C. Medina
Rahim F. Benekohal

A report prepared by
Traffic Operations Laboratory
Department of Civil and Environmental Engineering
University of Illinois at Urbana-Champaign

January 2006

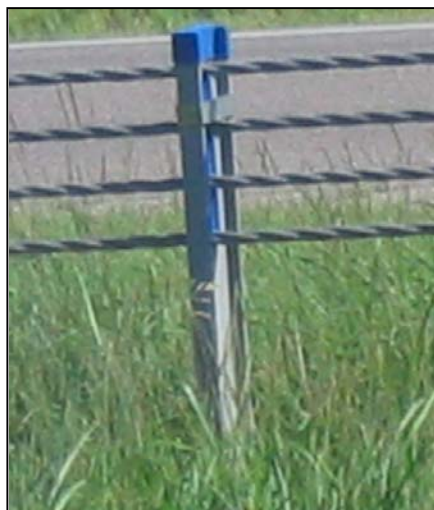
Figure 4. Safence System

Safence is a 4-cable WRSF system originally developed in Sweden by Blue Systems AB in 1993. Cables in the Safence system are factory pre-stretched. It uses I-section or C-section posts, which can be driven directly in the soil or installed in concrete cylinders. Spacers are placed between the cables to maintain adequate separation. Up to date, crashworthy end terminals have not been developed and tested.
