MnROAD / NCAT Pavement Preservation Visual Survey Record

Date	9/17/2021
Observer (s)	MnROAD Staff
Visual Documentation	Pictures
Report Developed	Yes / No - To date there are periodic updates only

Open Graded Friction Course on the MnROAD Low Volume Road

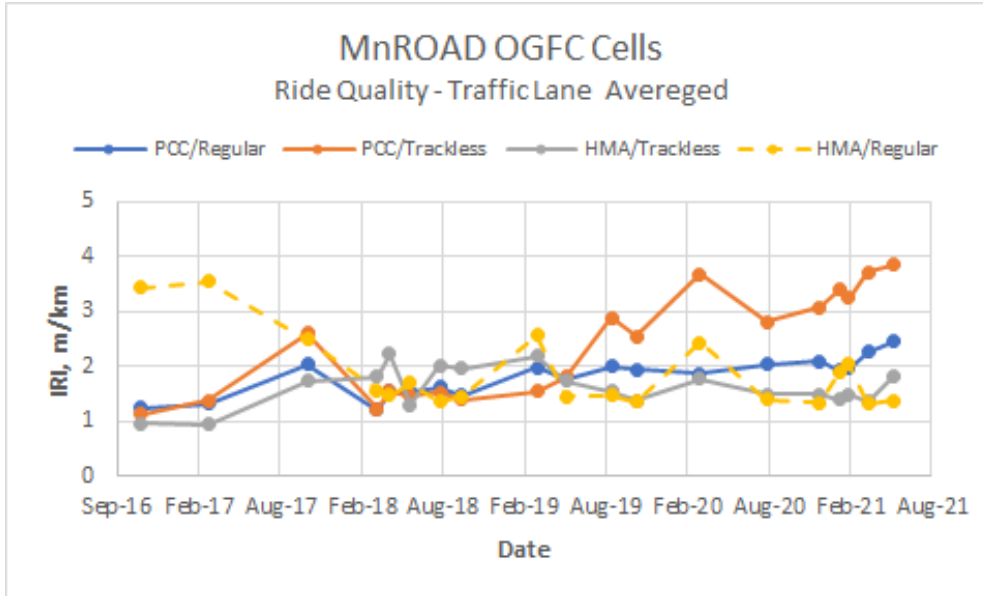
Figure 3 OGFC: Ride Quality of Trafficked (Inside) Lane.

Note the decline in roughness of the HMA/Regular cell that occurred in late 2017 and the increase of PCC/Non-Track cell in 2019 (Figure 3). Figure 4 also presents ride quality of the non-trafficked (outside) lane. Continued monitoring is planned.

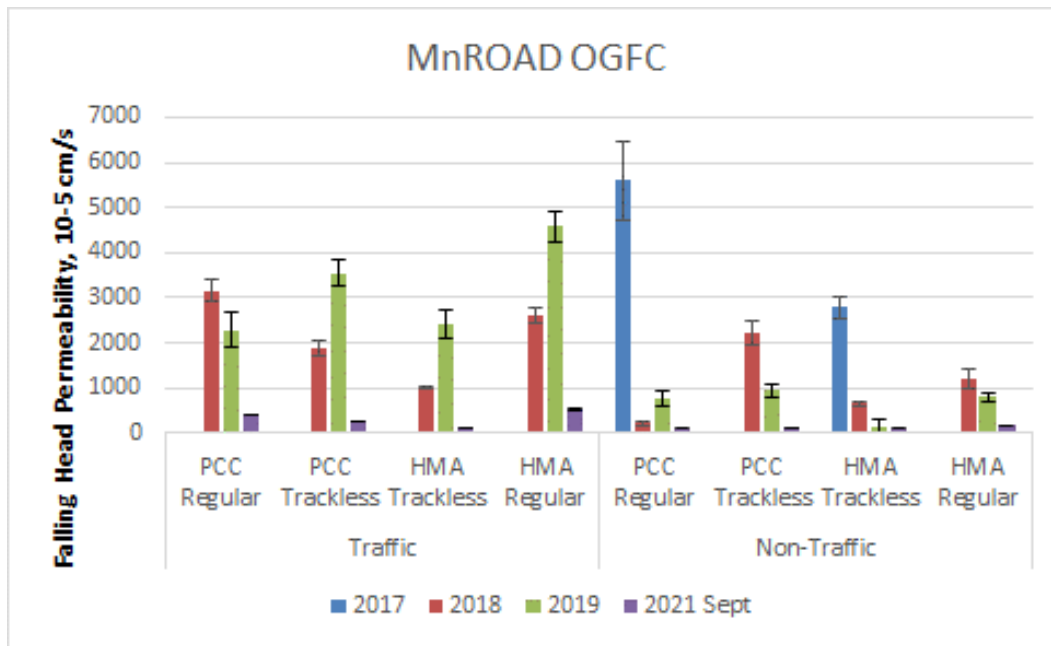
Figure 5 OGFC: Falling Head Permeability at Inside (Left Wheel Path) and Outside Lane (Between Wheel Paths).

A gate-valve permeameter was used to evaluate the water infiltration characteristics of OGFC installations. Several locations in the Environmental (Outside) Lane were tested for field permeability on June 1, 2017. Figure 5 shows that in 2018 permeability had declined at those points by 77 to 96 percent. In April of 2019 permeability had generally continued to decrease in the Outside Lane but had increased in the left wheel path of the Inside Lane. On September 17, 2021 single runs were performed at the test points and results showed that permeability was drastically reduced in both lanes. Results from the gate-valve device ranged between 112×10^{-5} and 518×10^{-5} cm/sec; suggesting that both lanes of the OGFC were performing like dense-graded bituminous pavement.

Continued monitoring is planned. The next round of measurements will include the gate-valve permeameter and, if warranted, a tiered, NCAT-style device that is suited for evaluating less permeable material.

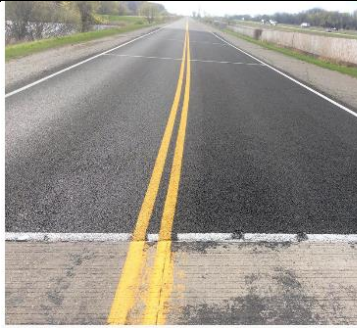
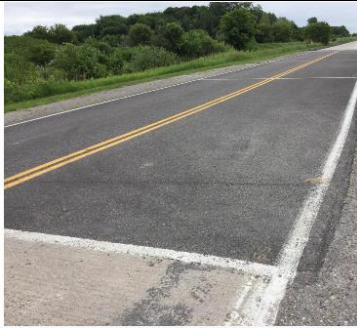
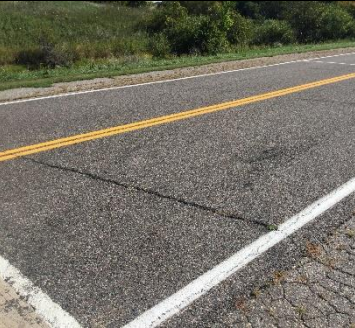
CELL	April 2017	July 2018	Sept 2021
<p align="center">55</p> <p>PCC/Reg Tack</p>

PCC/Reg Tack Non-Traffic Lane: 14x1 ft shoving in right wheel path noted on July 7, 2017 after construction activity.

Snapshots of the OGFC surface condition are shown in Figure 6. Traffic occurs in the left lane of each picture.

Figure 6 Photos of MnROAD OGFC Cells: Viewed Eastbound.

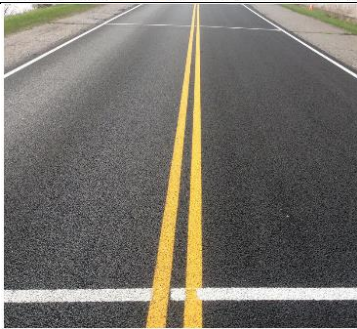
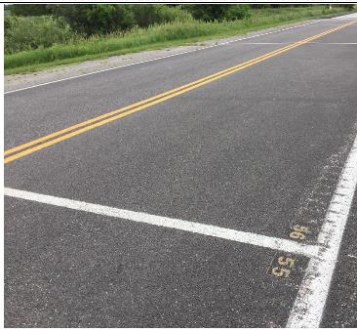
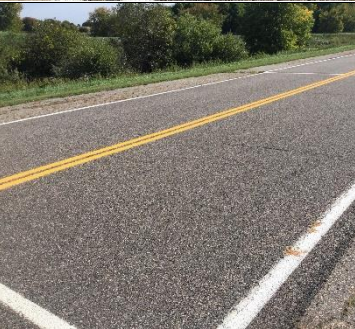
<p align="center">56</p> <p>PCC/ Trackless Tack</p>

PCC/Non-Track Tack: (*) Reflected crack at transition from PCC to HMA.
