# **Statewide Vinyl Bridge Paint Testing**

## **Statewide Environmental Study Report**

**Minnesota Department of Transportation  
The Office of Environmental Stewardship  
Environmental Modeling and Testing Unit**

**July 2013**

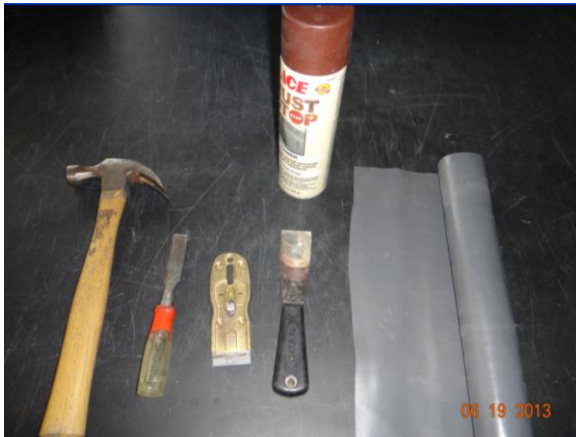
Figure 2.2.1: Vinyl paint sampling tools (spray paint, hammer, chisel, razor scraper, putty knife, and paint collection mat)

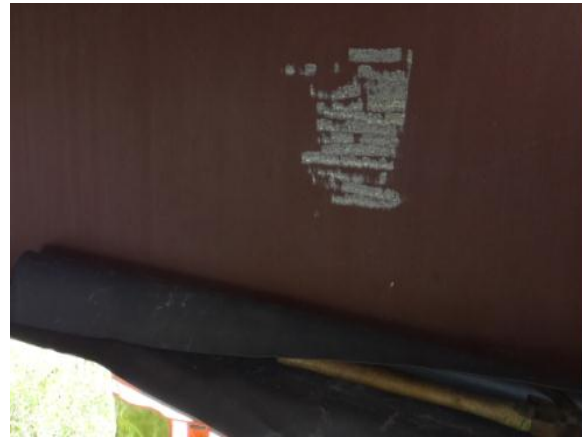
Figure 2.2.2: Example of a sampled bridge location

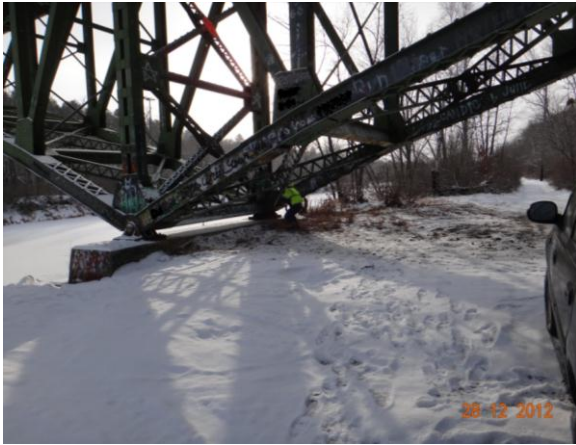
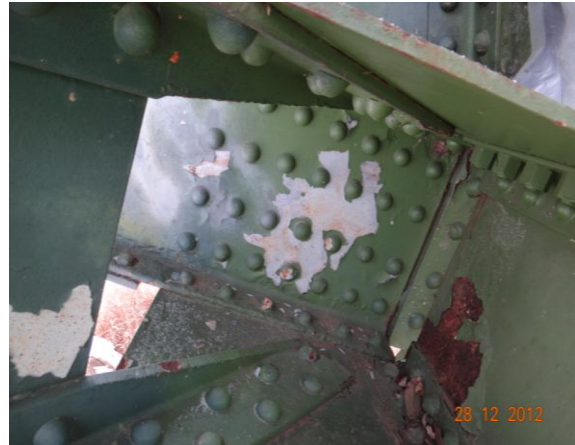
### **Bridge #5718**

*Figure 3.1.1: Bridge #5718 with waterway*

*Figure 3.1.2: Bridge #5718 sampling location*

No chromium, mercury, selenium, or silver was detected for Bridge #5718. The reported level of 0.14 mg/L for arsenic, 0.15 mg/L for barium, 0.25 mg/L for cadmium, and 1.4 mg/L for lead were all below regulatory maximum concentrations.

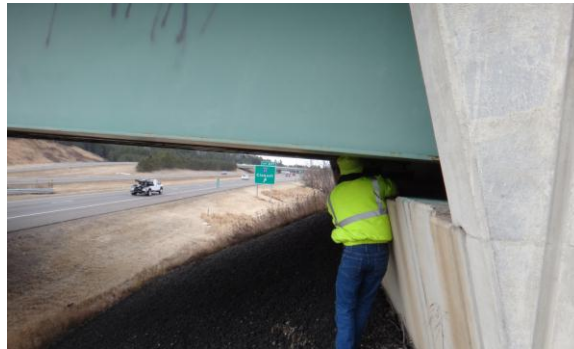
*Figure 3.1.3: Bridge #9837 sampling location with roadway*

No arsenic, chromium, lead, mercury, selenium, or silver was detected for Bridge #9837. Barium reported 0.18 mg/L and cadmium reported 0.22 mg/L; both are below the regulatory maximum concentrations.

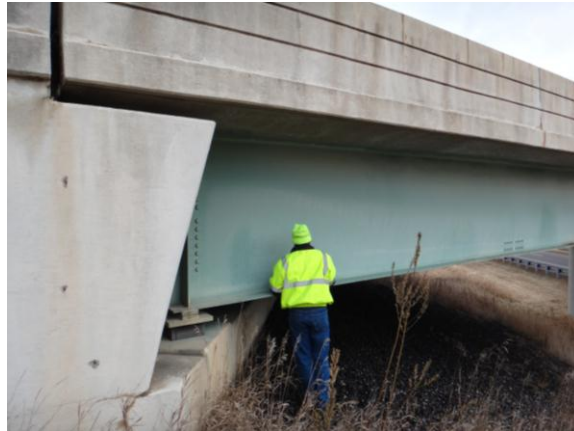
*Figure 3.1.4: Bridge #9838 sampling location with roadway*

No arsenic, chromium, mercury, selenium, or silver was detected for Bridge #9838. Barium reported 0.082 mg/L and lead reported 0.12 mg/L; both are below the regulatory maximum concentrations. Cadmium reported 0.74 mg/L which is within 0.26 mg/L of the regulated levels, but remained below the regulatory maximum concentration of 1.0 mg/L.

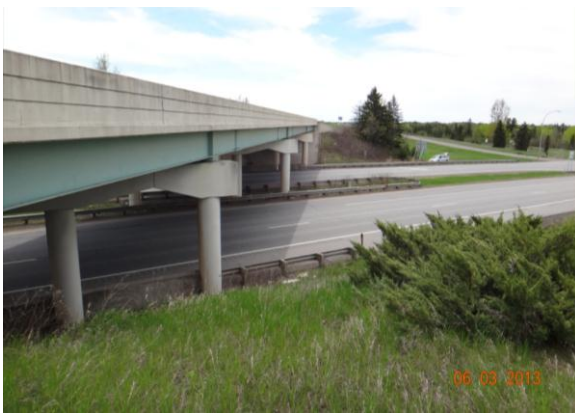
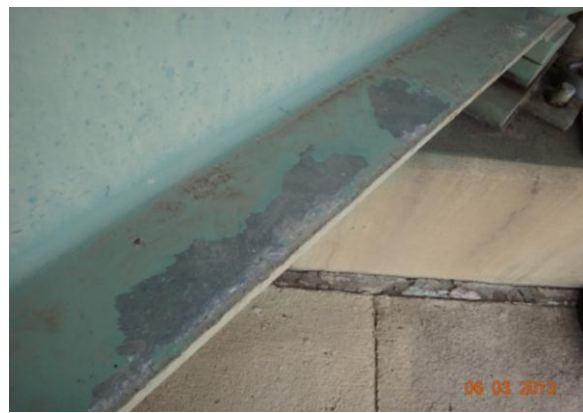
*Figure 3.1.5: Bridge #9188 with roadway*

*Figure 3.1.6: Bridge #9188 sampling location*

No arsenic, chromium, lead, mercury, selenium, or silver was detected for Bridge #9188. The reported level of 0.31 mg/L for barium and 0.072 mg/L for cadmium were both below regulatory maximum concentrations.

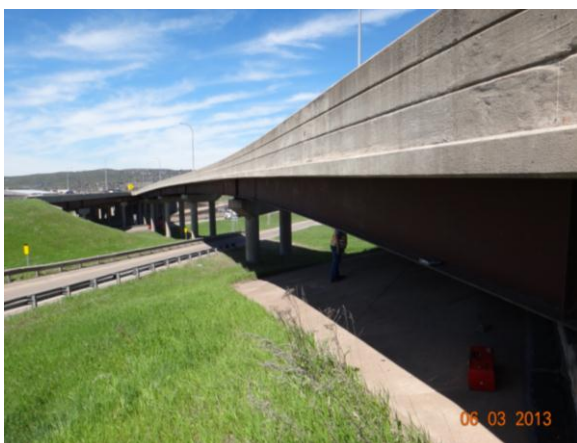
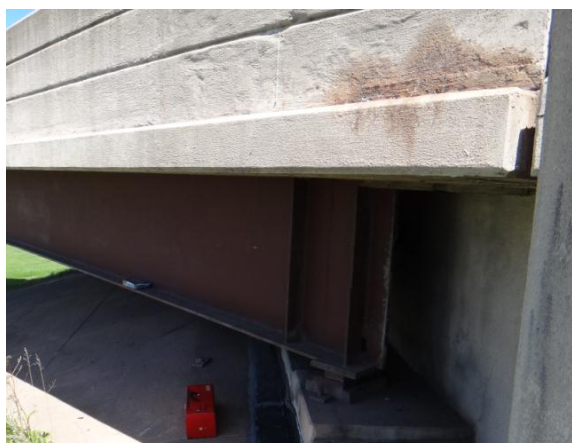
### **Bridge #69808A**

*Figure 3.1.7: Bridge #69808A with roadway*

*Figure 3.1.8: Bridge #69808A sampling location*

No arsenic, chromium, mercury, selenium, or silver was detected for Bridge #69808A. The reported level of 1.3 mg/L for barium, 0.10 mg/L for cadmium, and 1.0 mg/L for lead were all below regulatory maximum concentrations.

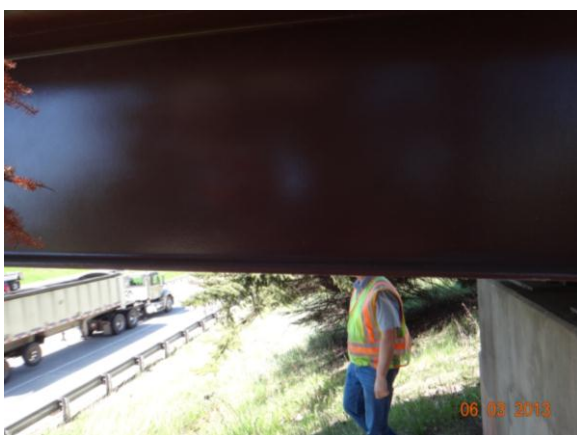
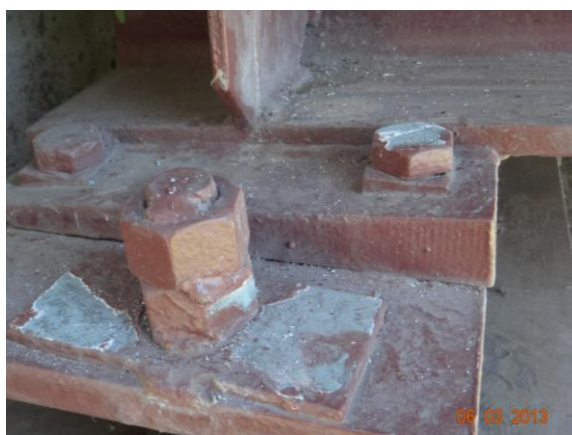
### **Bridge #69811**

*Figure 3.1.9: Bridge #69811 with roadway*

*Figure 3.1.10: Bridge #69811 sampling location*

No arsenic, chromium, mercury, selenium, or silver was detected for Bridge #69811. The reported level of 0.53 mg/L for barium, 0.12 mg/L for cadmium, and 0.12 mg/L for lead were all below regulatory maximum concentrations.

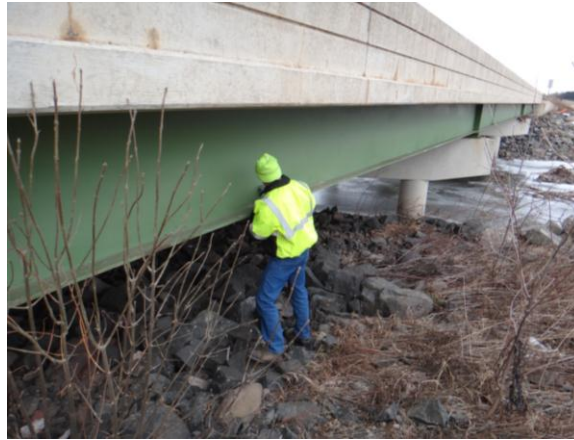
### **Bridge #9339**

*Figure 3.1.11: Bridge #9339 sampling location with waterway*

No chromium, mercury, selenium, or silver was detected for Bridge #9339. The reported level of 0.17 mg/L for arsenic, 0.27 mg/L for barium, 0.031 mg/L for cadmium, and 0.15 mg/L for lead were all below regulatory maximum concentrations.

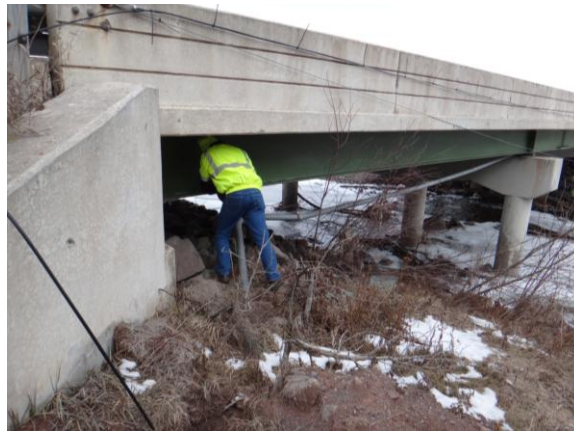
*Figure 3.1.12: Bridge #9341 sampling location with waterway*

No cadmium, chromium, mercury, selenium, or silver was detected for Bridge #9341. The reported level of 0.15 mg/L for arsenic, 0.11 mg/L for barium, and 0.045 mg/L for lead were all below regulatory maximum concentrations.

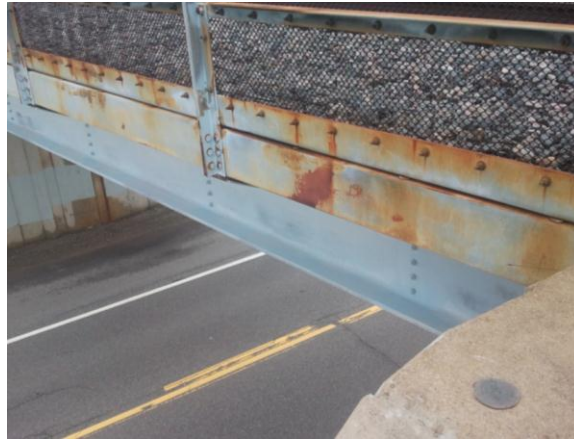
### **Bridge #9186**

*Figure 3.1.13: Bridge #9186 with roadway*

No cadmium, chromium, mercury, selenium, or silver were detected for Bridge #9186. There were reported levels of 0.085 mg/L for barium, and 0.048 mg/L for cadmium. In contrast, 59.8 mg/L was detected for lead. This sample exceeded the maximum federal standard of 5.0 mg/L for lead.

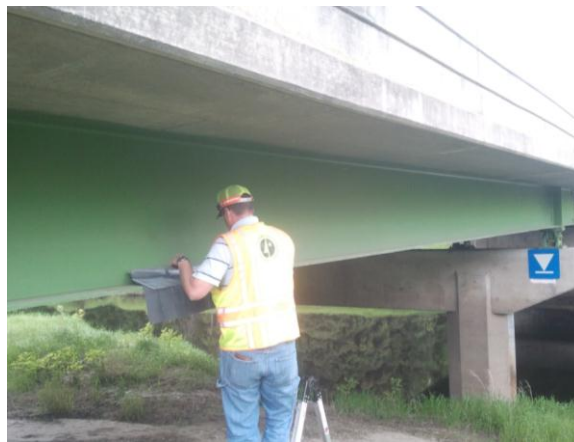
### **Bridge #6503**

*Figure 3.1.14: Bridge #6503 sampling location with waterway*

No cadmium, chromium, mercury, selenium, or silver were detected for Bridge #6503. There were reported levels of 0.085 mg/L, 0.048 mg/L, and 0.15 mg/L for barium, cadmium and lead, respectively. All of these concentrations were below the regulatory maximum concentration.

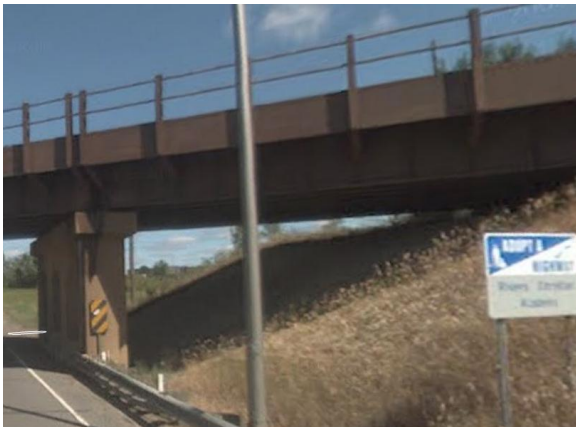
#### **Bridge #9480**

*Figure 3.2.1: Bridge #9480 with roadway*

No arsenic, barium, cadmium, chromium, mercury, selenium or silver was detected for Bridge #9480. However, lead concentrations were reported at 224 mg/L. This concentration is more than forty-five times greater than the USEPA regulatory maximum concentrations of 5.0 mg/L.

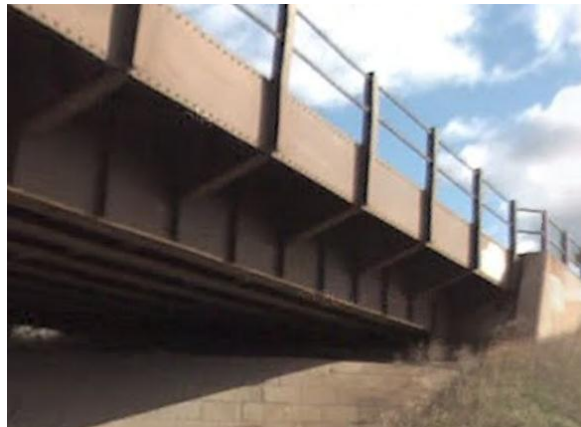
*Figure 3.2.2: Bridge #9480 sample location*

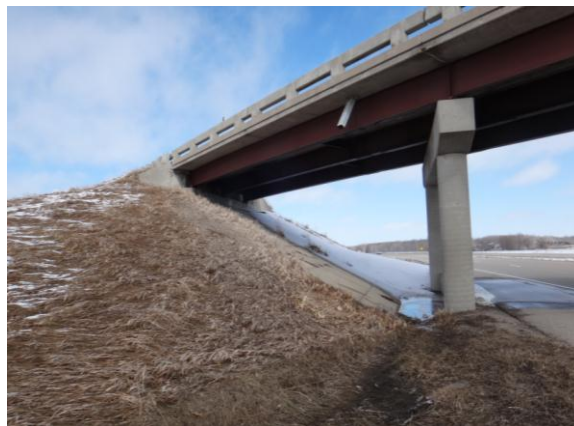
*Figure 3.2.3: Bridge #73818 with roadway*

No arsenic, chromium, mercury, selenium, or silver was detected for Bridge #73818. The reported level of 0.14 mg/L for barium, 0.089 mg/L for cadmium, and 1.1 mg/L for lead were all below regulatory maximum concentrations.

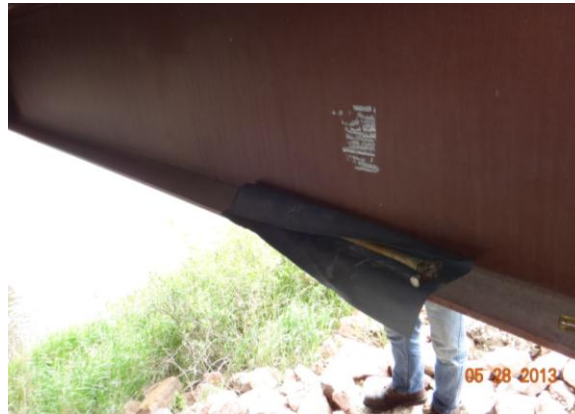
#### **Bridge #67806**

*Figure 3.3.1: Bridge #67806 sampling location with waterway*

No arsenic, chromium, mercury, selenium, or silver was detected for Bridge #67806. The reported level of 0.13 mg/L for barium, 0.26 mg/L for cadmium, and 1.0 mg/L for lead were all below regulatory maximum concentrations.

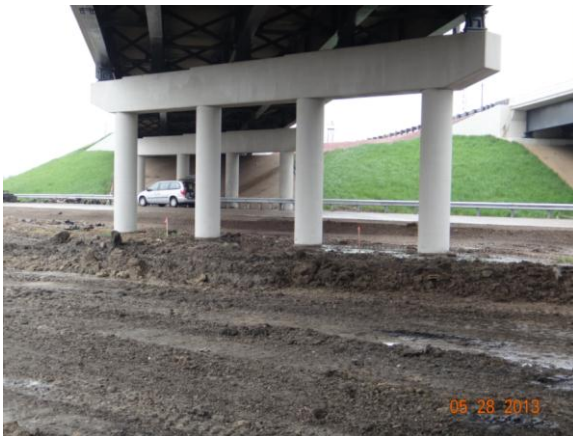
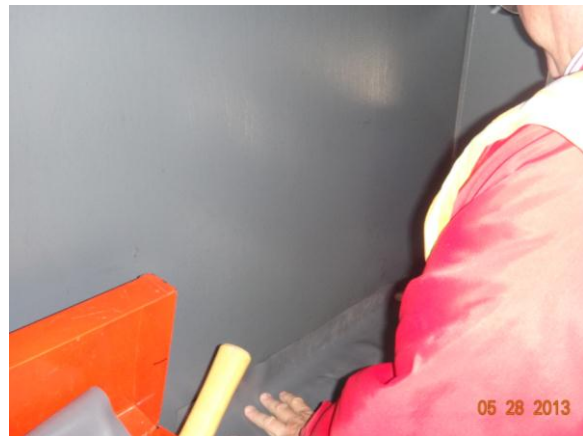
#### **Bridge #53820**

*Figure 3.3.2: Bridge #53820 with roadway*

*Figure 3.3.3: Bridge #53820 sampling location*

No arsenic, cadmium, chromium, mercury, selenium, or silver was detected for Bridge #53820. The reported level of 0.057 mg/L for barium and 0.057 mg/L for lead were both below regulatory maximum concentrations.

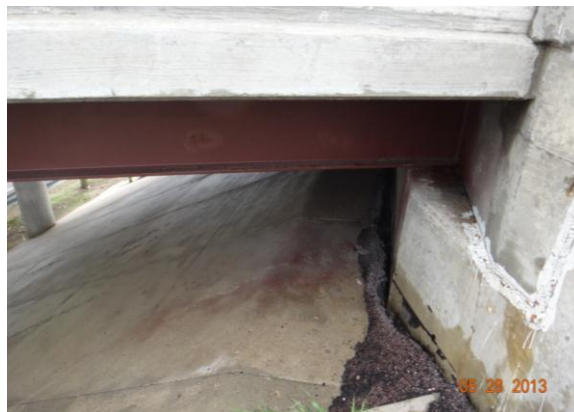
*Figure 3.3.4: Bridge #67801 sampling location with roadway shoulder*

No arsenic, chromium, mercury, selenium, or silver was detected for Bridge #67801. The reported level of 0.17 mg/L for barium, 0.21 mg/L for cadmium, and 0.83 mg/L for lead were all below regulatory maximum concentrations.

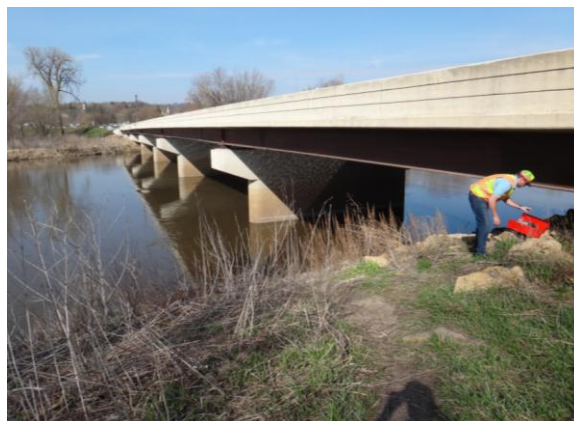
*Figure 3.3.5: Bridge #40001 sampling location with waterway*

No arsenic, chromium, mercury, selenium, or silver was detected for Bridge #40001. The reported level of 0.14 mg/L for barium, 0.046 mg/L for cadmium, and 0.66 mg/L for lead were all below regulatory maximum concentrations.

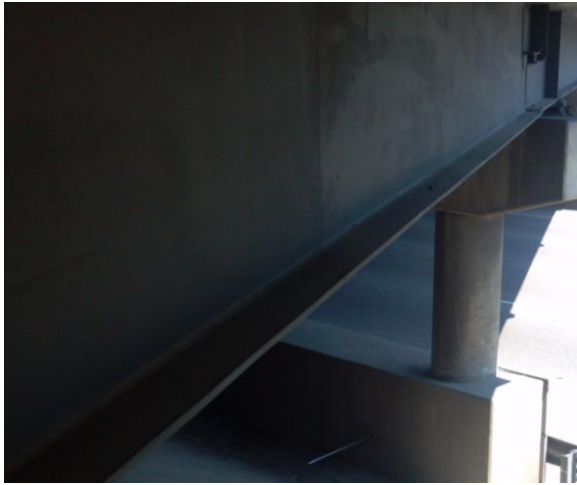
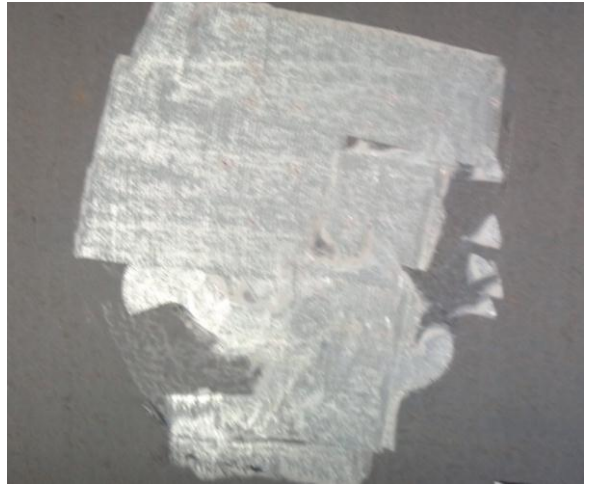
### **Bridge #27869**

*Figure 3.4.1: Bridge #27869 with roadway*

*Figure 3.4.2: Bridge #27869 sampling location*

No arsenic, chromium, mercury, selenium, or silver was detected for Bridge #27869. Reported level of 0.49 mg/L for barium, 0.16 mg/L for cadmium, and 0.69 mg/L for lead were below the regulatory maximum concentration.

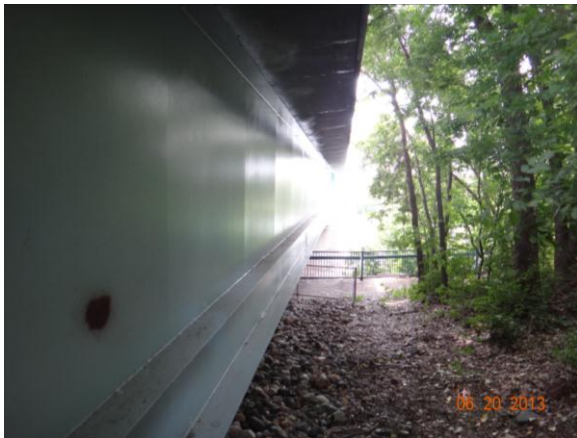
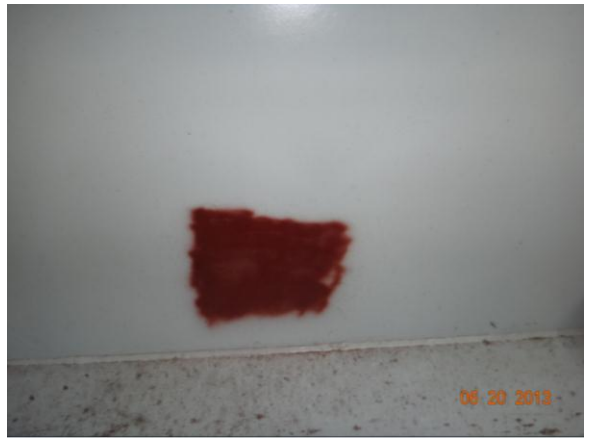
### **Bridge #27549A**

*Figure 3.4.3: Bridge #27549A with waterway*

*Figure 3.4.4: Bridge #27549A sampling location*

No arsenic, cadmium, chromium, lead, mercury, selenium, or silver was detected for Bridge #27549A. The reported level of 4.9 mg/L for barium is below the regulatory maximum concentration.

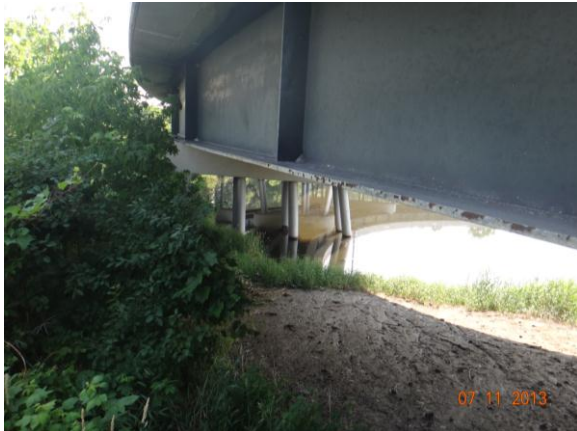
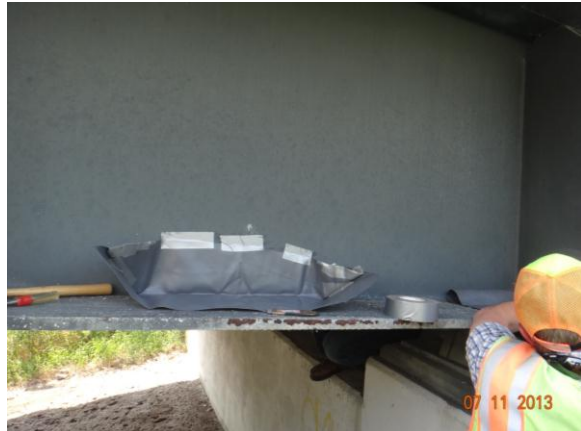
### **Bridge #27031A**

*Figure 3.4.5: Bridge #27031A with roadway*

*Figure 3.4.6: Bridge #27031A sampling location*

No arsenic, chromium, mercury, selenium, or silver was detected for Bridge #27031A. The reported levels of 0.37 mg/L for barium, 0.19 mg/L for cadmium, and 0.44 mg/L for lead were below the regulatory maximum concentration.

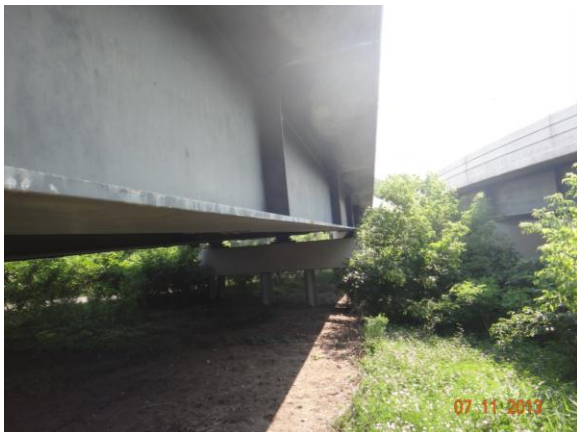
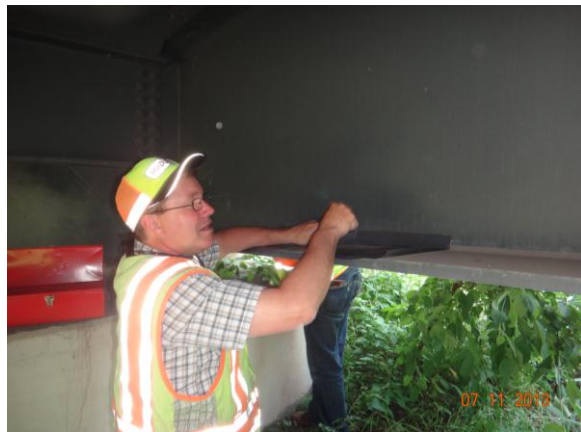
### **Bridge #27031B**

*Figure 3.4.7: Bridge #27031B*

*Figure 3.4.8: Bridge #27031B sampling location*

No arsenic, chromium, mercury, selenium, or silver was detected for Bridge #27031B. The reported levels of 0.30 mg/L for barium, 0.90 mg/L for cadmium, and 0.40 mg/L for lead were below the regulatory maximum concentration.

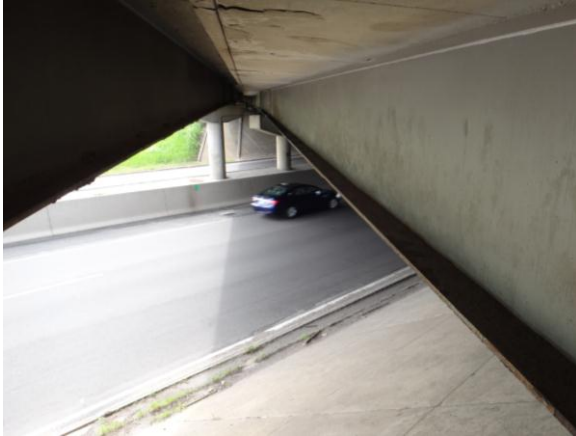
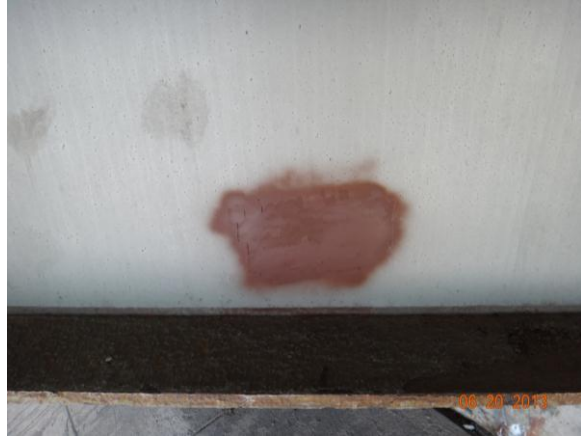
### **Bridge #27038**

*Figure 3.4.9: Bridge #27038 with roadway*

*Figure 3.4.10: Bridge #27038 sampling location*

No arsenic, chromium, mercury, selenium, or silver was detected for Bridge #27038. The reported level of 0.12 mg/L for barium 0.31 mg/l for lead and 0.13 mg/L for cadmium were both below regulatory maximum concentrations.

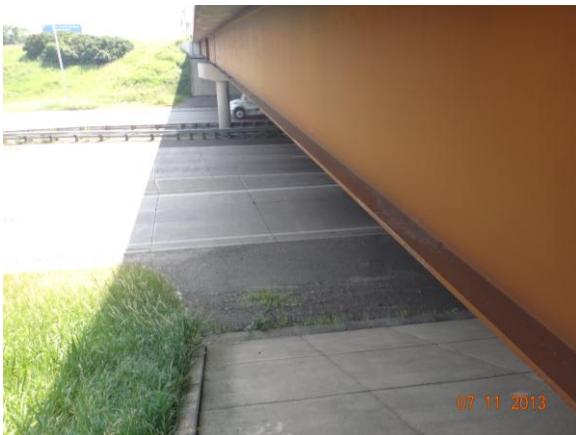
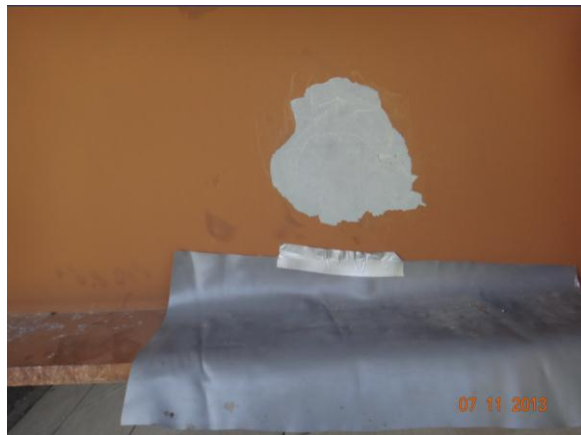
### **Bridge #27033**

*Figure 3.4.11: Bridge #27033 with roadway*

*Figure 3.4.12: Bridge #27033 sampling location*

No arsenic, mercury, selenium, or silver was detected for Bridge #27033. The reported levels of 0.40 mg/L for barium, 0.15 mg/L for cadmium, 0.079 mg/L for chromium, and 0.19 mg/L for lead were below regulatory maximum concentrations.

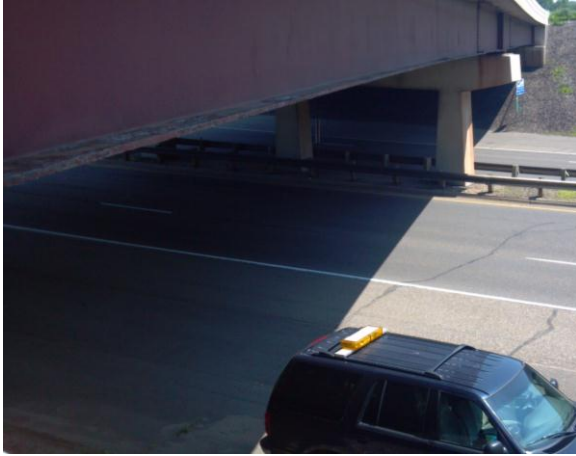
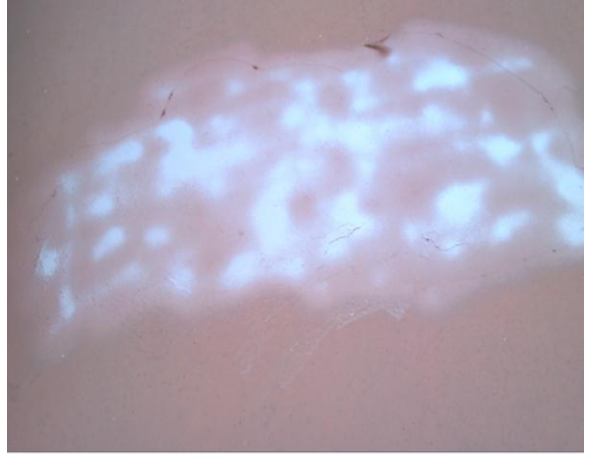
### **Bridge #82849**

*Figure 3.4.13: Bridge #82849 with roadway*

*Figure 3.4.14: Bridge #82849 sampling location*

No arsenic, chromium, mercury, selenium, or silver was detected for Bridge #82849. The reported levels of 0.83 mg/L for barium, 0.17 mg/L for cadmium, and 0.13 mg/L for lead were below regulatory maximum concentrations.

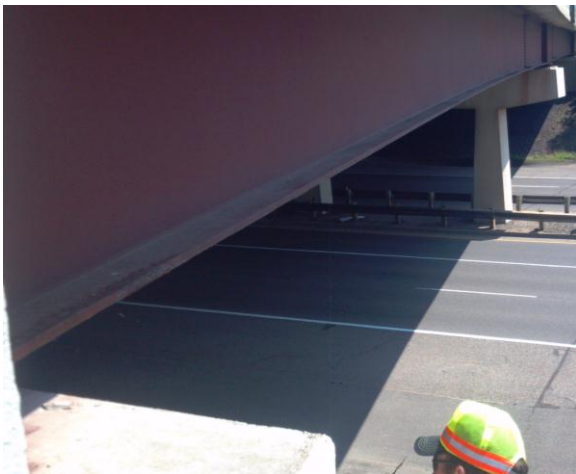
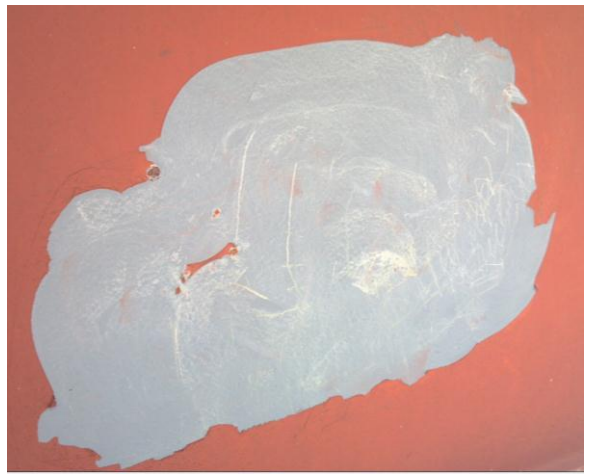
### **Bridge #82850**

*Figure 3.4.15: Bridge #82850 with roadway*

*Figure 3.4.16: Bridge #82850 sampling location*

No arsenic, chromium, mercury, selenium, or silver was detected for Bridge #82850. The reported levels of 0.72 mg/L for barium, 0.091 for cadmium, and 0.13 for lead were below regulatory maximum concentrations.

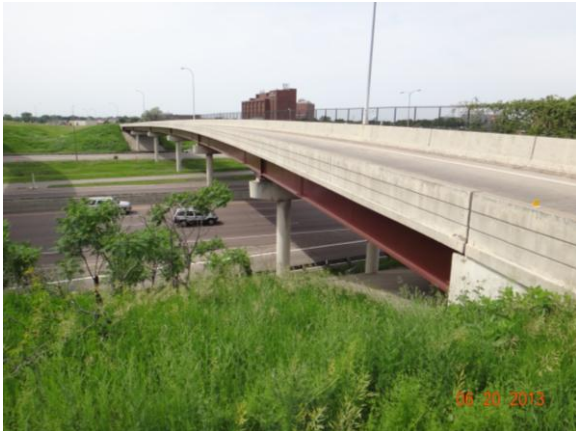
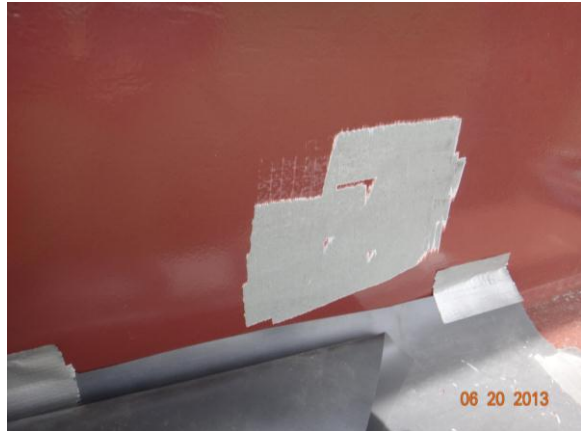
### **Bridge #27913**

*Figure 3.4.17: Bridge #27913 with roadway*

*Figure 3.4.18: Bridge #27913 sampling location*

No arsenic, cadmium, chromium, lead, mercury, selenium, or silver was detected for Bridge #27913. The reported level of 0.055 mg/L for barium is below the regulatory maximum concentration.

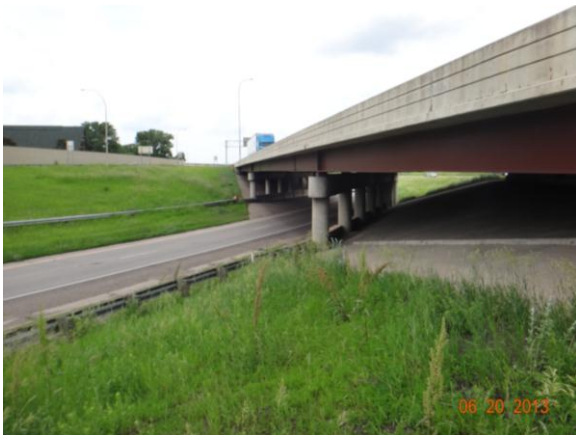
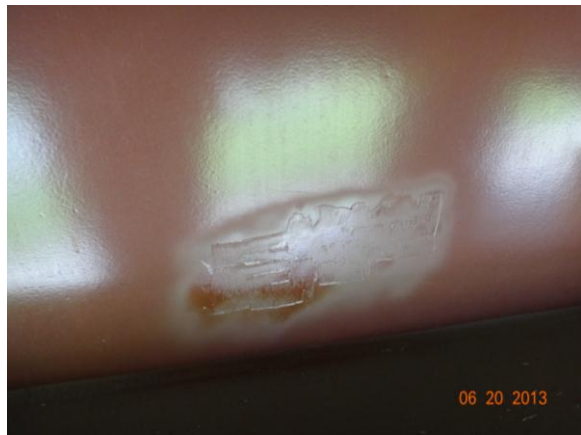
### **Bridge #27734**

*Figure 3.4.19: Bridge #27734 with roadway*

*Figure 3.4.20: Bridge #27734 sampling location*

No arsenic, chromium, mercury, selenium, or silver was detected for Bridge #27734. The reported level of 10.3 mg/L for barium, 0.029 mg/L for cadmium, and 0.22 mg/L for lead were below regulatory maximum concentrations.

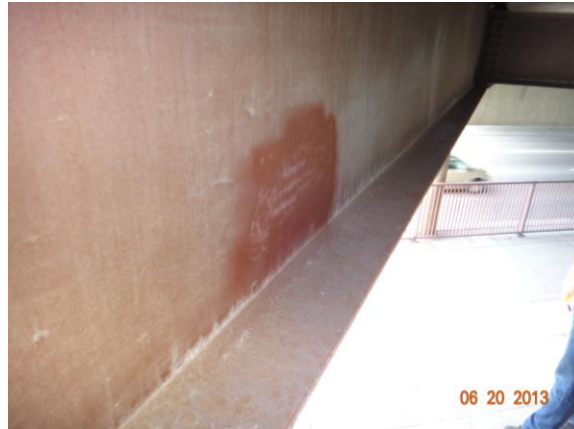
*Figure 3.4.21: Bridge #27924 sampling location with roadway*

No arsenic, chromium, mercury, selenium, or silver was detected for Bridge #27924. The reported level of 0.18 mg/L for barium, 0.087 mg/L for cadmium, and 0.60 mg/L for lead were below regulatory maximum concentrations.

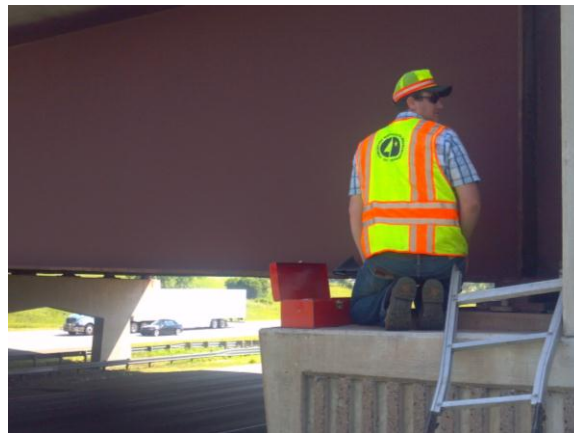
### **Bridge #82846**

*Figure 3.4.22: Bridge #82846 sampling location with roadway*

No arsenic, chromium, mercury, selenium, or silver was detected for Bridge #82846. The reported level of 0.45 mg/l for barium, 0.21 mg/l for cadmium, 0.61 mg/L for lead were below regulatory maximum concentrations.

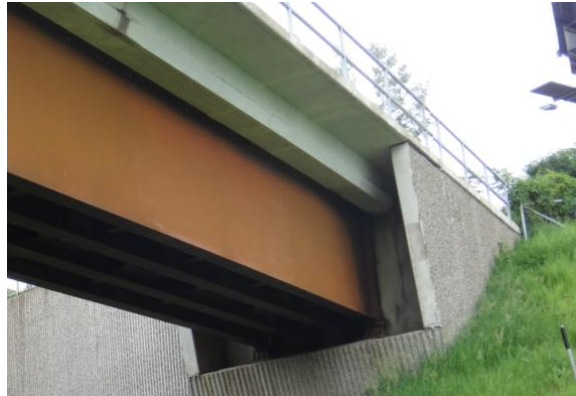
*Figure 3.4.23: Bridge #19829 sampling location*

No arsenic, chromium, mercury, selenium, or silver was detected for Bridge #19829. The reported level of 0.54 mg/L for barium, 0.099 mg/L for cadmium, and 0.057 mg/L for lead were below regulatory maximum concentrations.

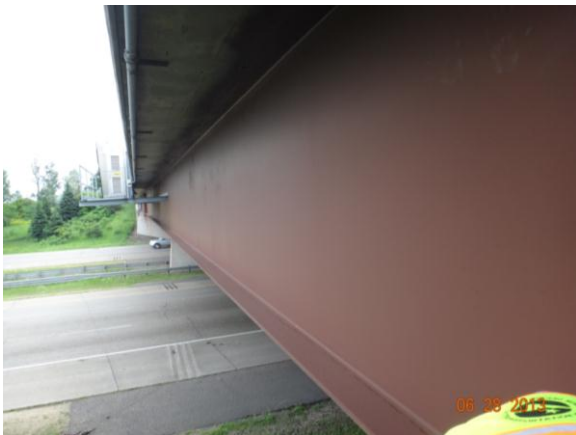
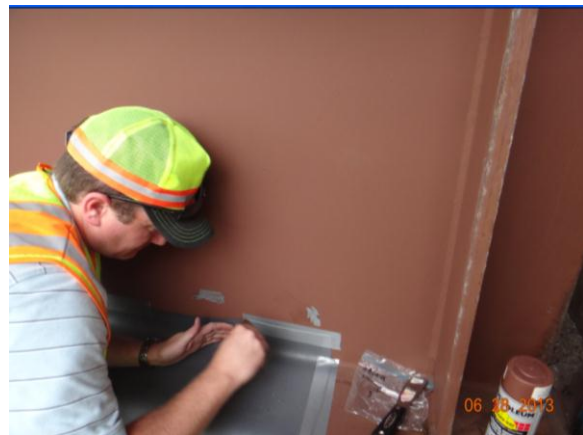
### **Bridge #82844**

*Figure 3.4.24: Bridge #82844 with roadway*

*Figure 3.4.25: Bridge #82844 sampling location*

No arsenic, chromium, mercury, selenium, or silver was detected for Bridge #82844. The reported level of 0.19 mg/L for barium, 0.27 mg/L for cadmium, and 0.96 mg/L for lead were below regulatory maximum concentrations.

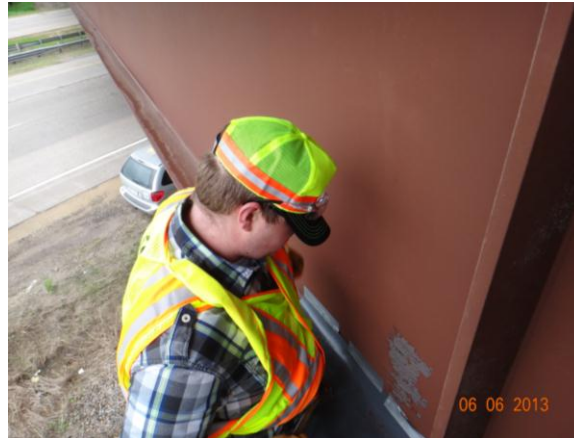
### **Bridge #82848**

*Figure 3.4.26: Bridge #82848 sampling location with roadway*

No arsenic, chromium, mercury, selenium, or silver was detected for Bridge #82848. The reported level of 0.32 mg/L for barium, 0.43 mg/L for cadmium, and 1.5 mg/L for lead were below regulatory maximum concentrations.

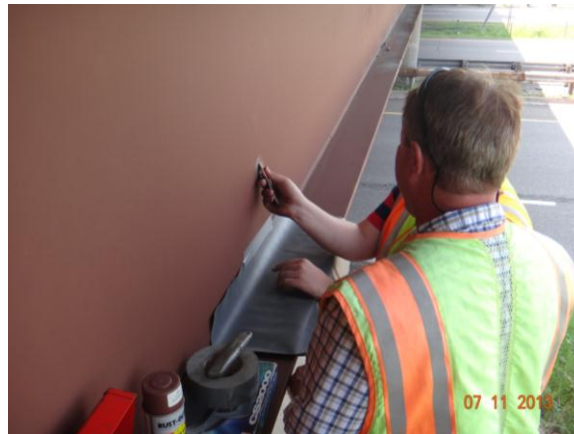
### **Bridge #27079**

*Figure 3.4.27: Bridge #27079 with roadway*

No arsenic, chromium, mercury, selenium, or silver was detected for Bridge #27079. The reported level of 0.42 mg/L for barium, 0.23 mg/L for cadmium, and 2.7 mg/L for lead were below regulatory maximum concentrations.

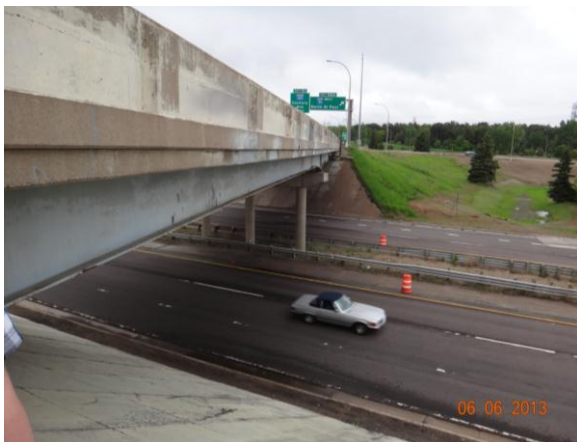
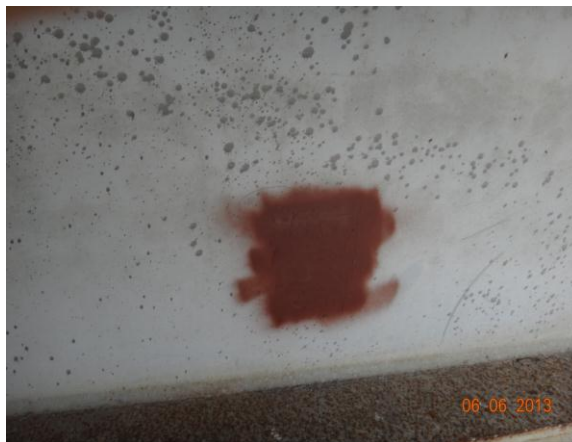
### **Bridge #82814**

*Figure 3.4.28: Bridge #82814 with roadway*

*Figure 3.4.29: Bridge #82814 sampling location*

No arsenic, chromium, mercury, selenium, or silver was detected for Bridge #82814. The reported level of 0.16 mg/L for barium, 0.16 mg/L for cadmium, and 0.18 mg/L for lead were below regulatory maximum concentrations.

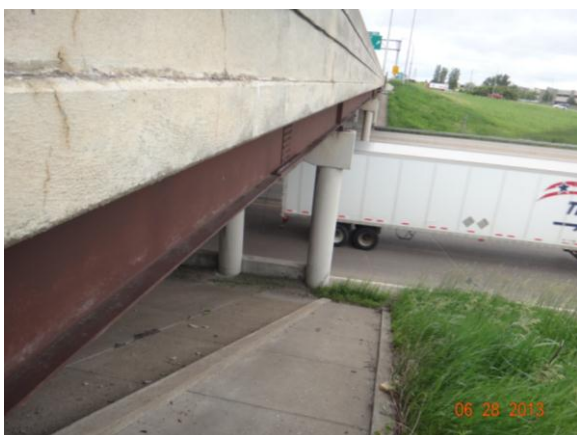
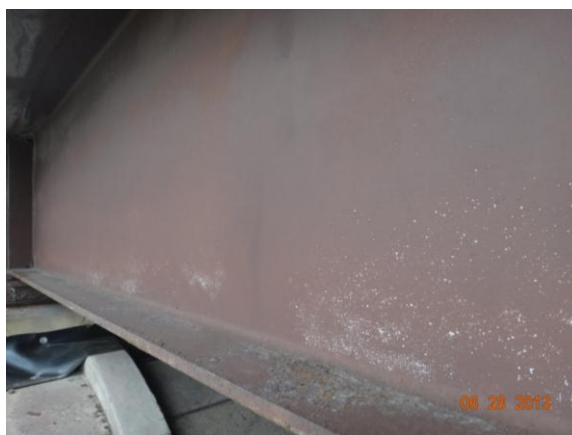
### **Bridge #82832**

*Figure 3.4.30: Bridge #82832 with roadway*

*Figure 3.4.31: Bridge #82832 sampling location*

No arsenic, chromium, mercury, selenium, or silver was detected for Bridge #82832. The reported level of 0.65 mg/L for barium, 0.029 mg/L for cadmium, and 0.66 mg/L for lead were below regulatory maximum concentrations.

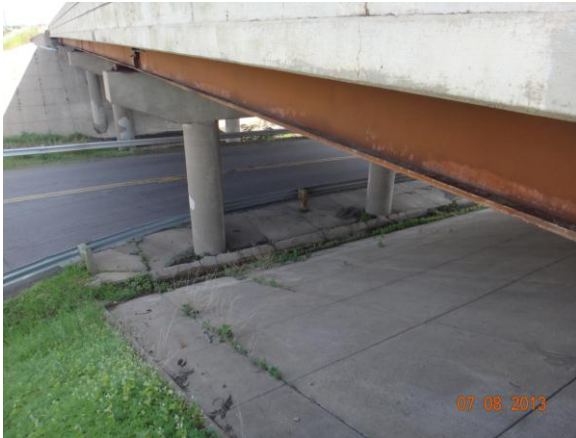
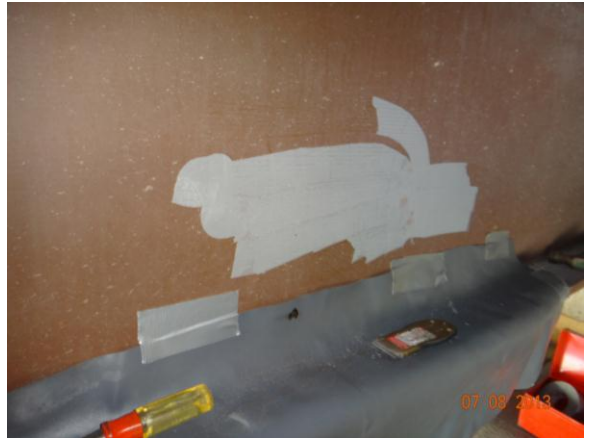
### **Bridge #9351**

*Figure 3.4.32: Bridge #9351 with roadway*

*Figure 3.4.33: Bridge #9351 sampling location*

No arsenic, mercury, selenium, or silver was detected for Bridge #9351. The reported level of 0.31 mg/L for barium, 0.11 mg/L for cadmium, 0.066 mg/L for chromium, and 0.34 mg/L for lead were below regulatory maximum concentrations.

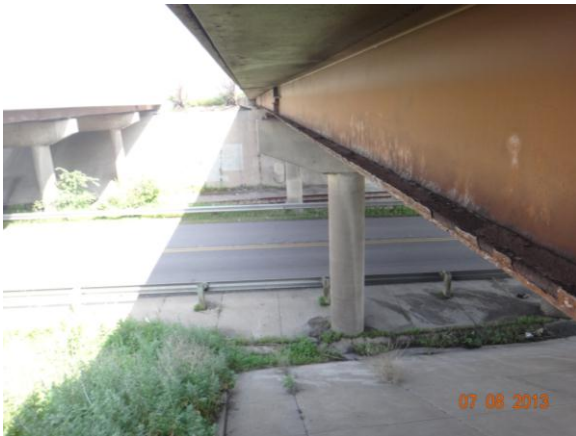
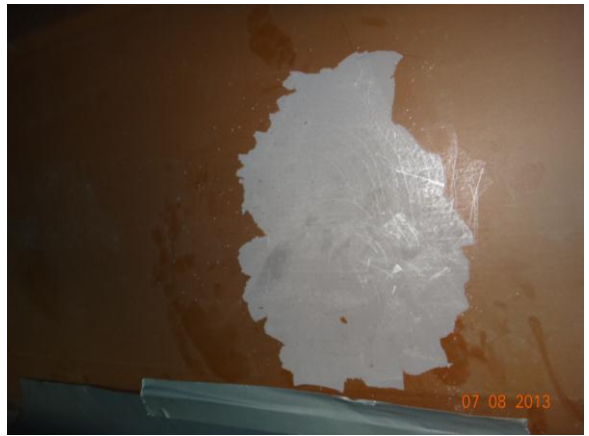
### **Bridge #9352**

*Figure 3.4.34: Bridge #9352 with roadway*

*Figure 3.4.35: Bridge #9352 sampling location*

No arsenic, mercury, selenium, or silver was detected for Bridge #9352. The reported level of 0.63 mg/L for barium, 0.30 mg/L for cadmium, 0.18 mg/L for chromium, and 0.41 mg/L for lead were below regulatory maximum concentrations.

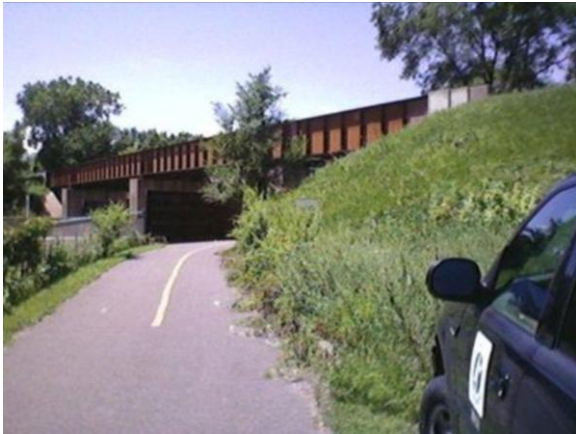
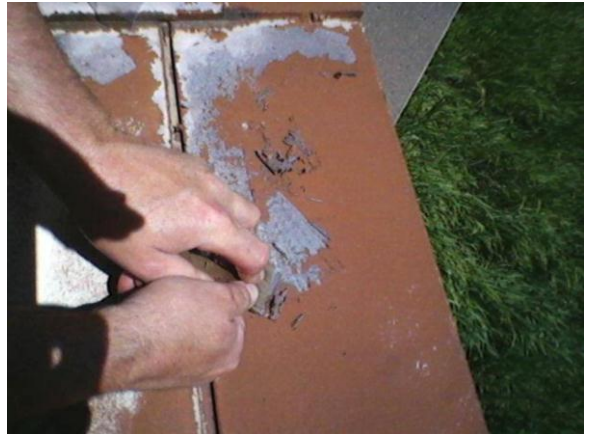
### **Bridge #9390**

*Figure 3.4.36: Bridge #9390 with roadway*

*Figure 3.4.37: Bridge #9390 sampling location*

No arsenic, chromium, mercury, selenium, or silver were detected for Bridge #9390. The reported levels of 0.29 mg/L for barium, 0.11 mg/L for cadmium, and 0.41 mg/L for lead were below regulatory maximum concentrations.

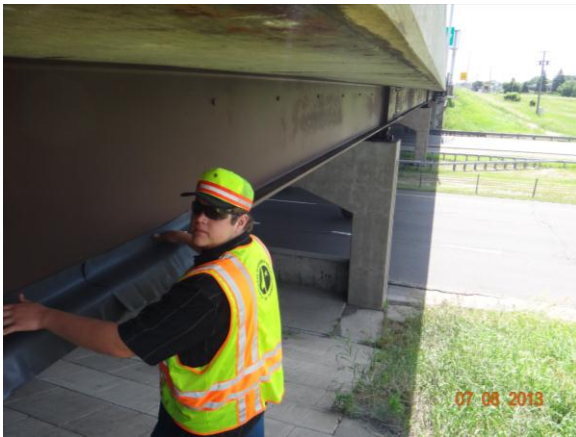
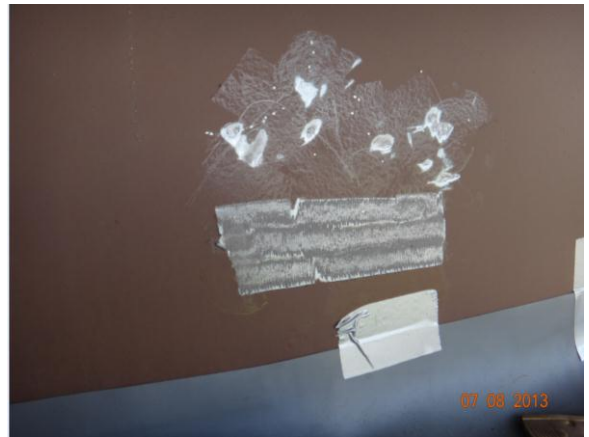
### **Bridge #9012**

*Figure 3.4.38: Bridge #9012 with roadway*

*Figure 3.4.39: Bridge #9012 sampling location*

No arsenic, chromium, mercury, selenium, or silver were detected for Bridge #9012. The reported levels of 0.32 mg/L of barium, 0.35 mg/L of cadmium, and 0.24 mg/L of lead were below regulatory maximum concentrations.

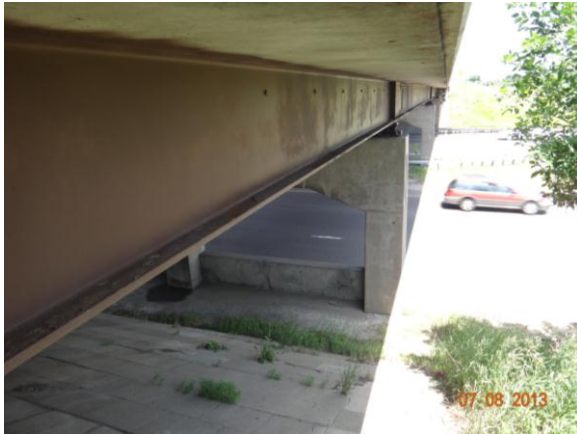
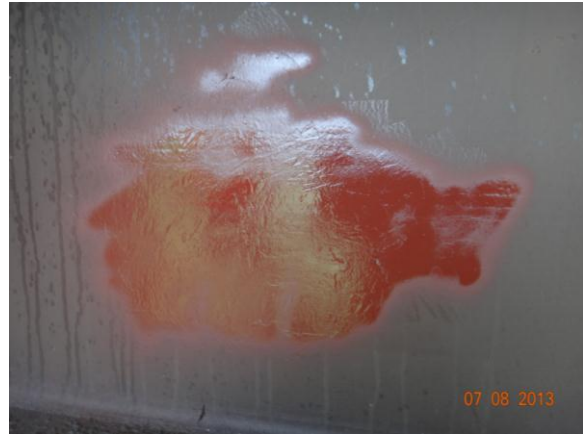
### **Bridge #9013**

*Figure 3.4.40: Bridge #9013 with roadway*

*Figure 3.4.41: Bridge #9013 sampling location*

No arsenic, chromium, mercury, selenium, or silver was detected for Bridge #9013. The reported level of 0.56 mg/L for barium, 0.68 mg/L for cadmium, and 0.19 mg/L for lead were below regulatory maximum concentrations.

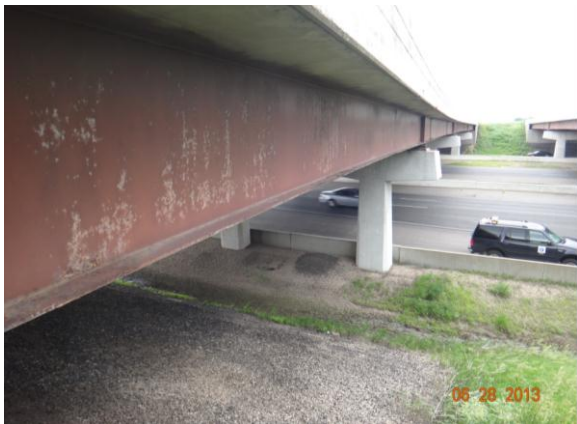
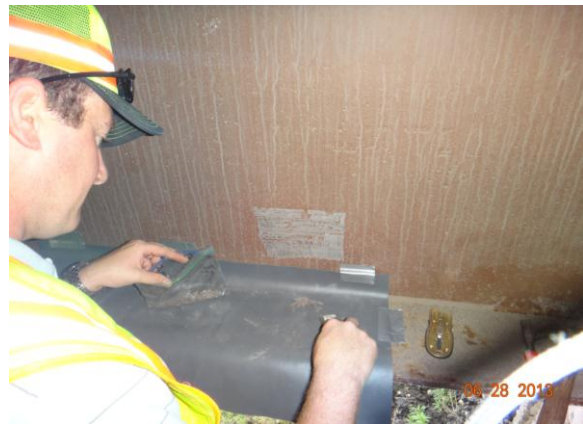
*Figure 3.4.42: Bridge #19823 with roadway*

*Figure 3.4.43: Bridge #19823 sampling location*

No arsenic, chromium, mercury, selenium, or silver was detected for Bridge #19823. The reported level of 0.74 mg/L for barium, 0.13 mg/L for cadmium, and 0.19 mg/L for lead were below regulatory maximum concentrations.

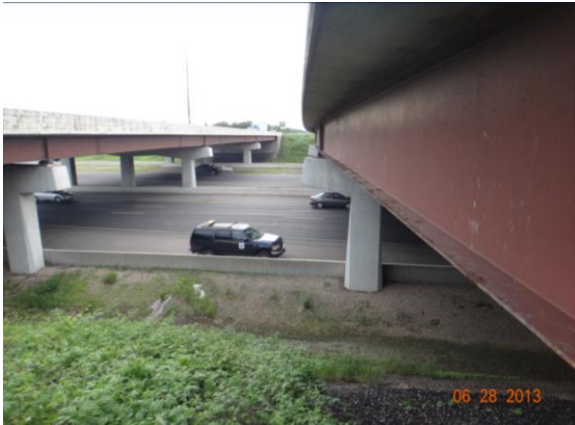
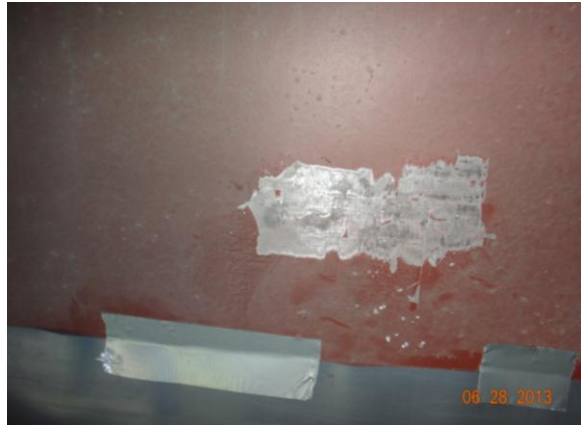
*Figure 3.4.44: Bridge #19824 with roadway*

*Figure 3.4.45: Bridge #19824 sampling location*

No arsenic, chromium, mercury, selenium, or silver was detected for Bridge #19824. The reported level of 0.67 mg/L for barium, 0.11 mg/L for cadmium, and 0.26 mg/L for lead were below regulatory maximum concentrations.

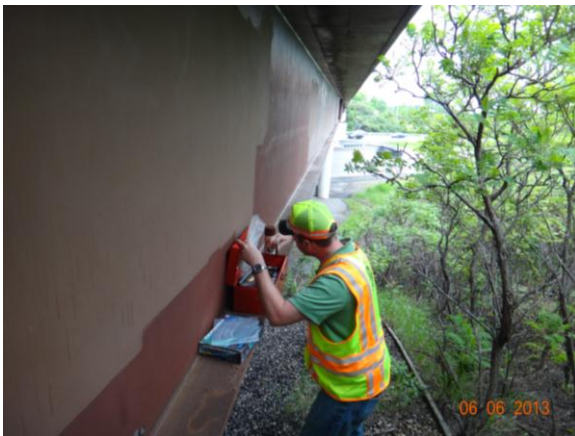
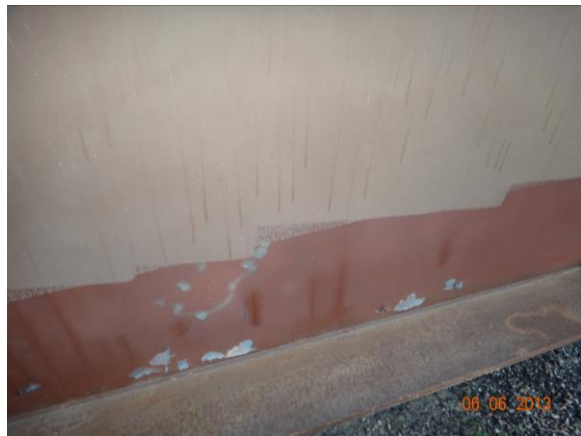
### **Bridge #19882**

*Figure 3.4.46: Bridge #19882 with roadway*

*Figure 3.4.47: Bridge #19882 sampling location*

No arsenic, chromium, mercury, selenium, or silver was detected for Bridge #19882. The reported level of 0.30 mg/L for barium, 0.42 mg/L for cadmium, and 0.23 mg/L for lead were below regulatory maximum concentrations.

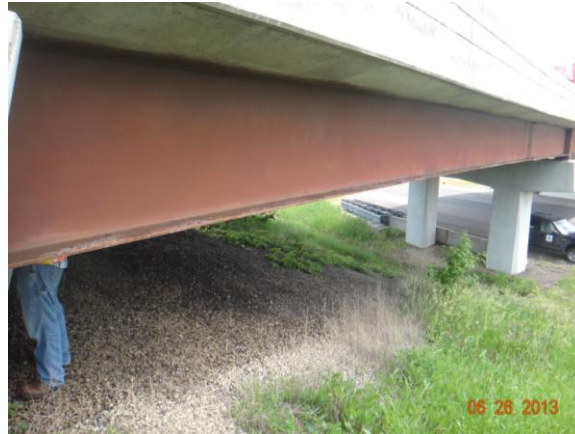
### **Bridge #19899**

*Figure 3.4.48: Bridge #19889 sampling location with roadway*

No arsenic, chromium, mercury, selenium, or silver was detected for Bridge #19899. The reported level of 0.54 mg/L for barium, 0.13 mg/L for cadmium, and 0.24 mg/L for lead were below regulatory maximum concentrations.

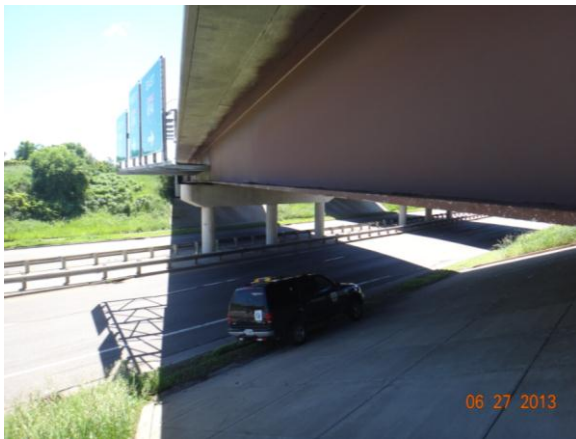
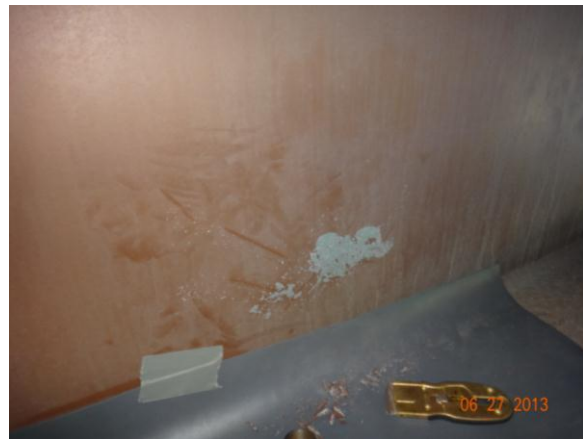
### **Bridge #19037**

*Figure 3.4.49: Bridge #19037 with roadway*

*Figure 3.4.50: Bridge #19037 sampling location*

No arsenic, chromium, mercury, selenium, or silver was detected for Bridge #19037. The reported level of 0.14 mg/L for barium, 0.020 mg/L for cadmium, and 0.84 mg/L for lead were below regulatory maximum concentrations.

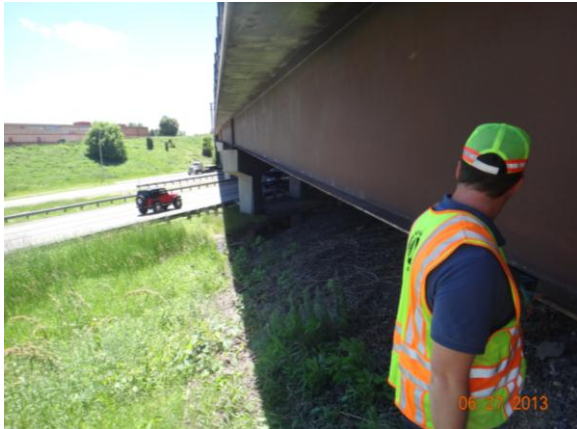
*Figure 3.4.51: Bridge #19832 with roadway*
