# **Statewide Vinyl Bridge Paint Testing**

## **Statewide Environmental Study Report**

**Minnesota Department of Transportation  
The Office of Environmental Stewardship  
Environmental Modeling and Testing Unit**

**July 2013**

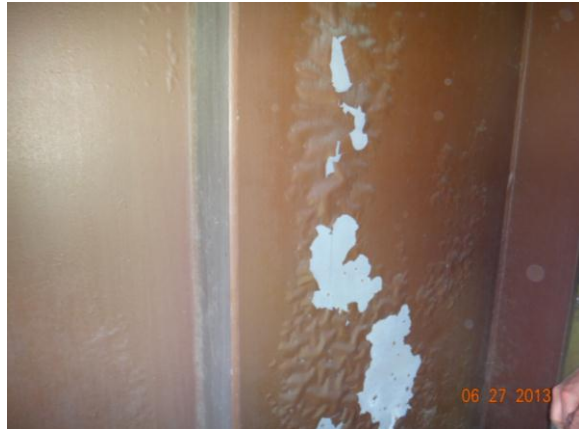
### **Bridge #19832**

*Figure 3.4.52: Bridge #19832 sampling location*

No arsenic, chromium, mercury, selenium, or silver was detected for Bridge #19832. The reported level of 0.059 mg/L for barium, 0.023 mg/L for cadmium, and 0.84 mg/L for lead were below regulatory maximum concentrations.

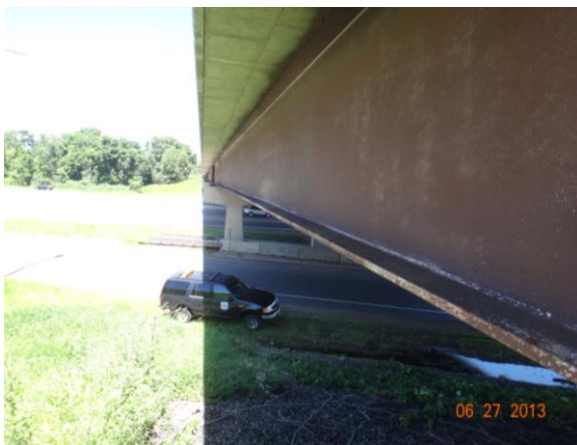
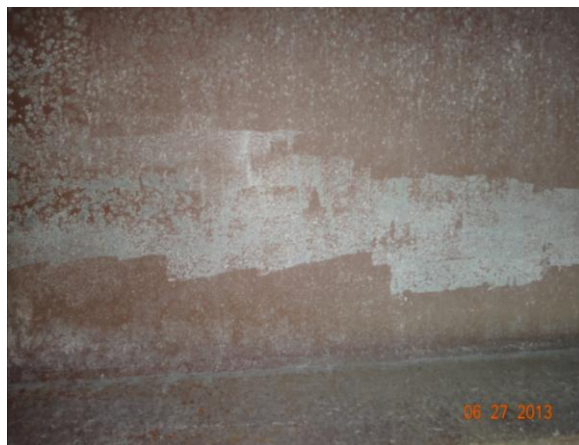
### **Bridge #19854**

*Figure 3.4.53: Bridge #19854 with roadway*

*Figure 3.4.54: Bridge #19854 sampling location*

No arsenic, cadmium, chromium, mercury, selenium, or silver was detected for Bridge #19854. The reported level of 0.18 mg/L for barium and 0.17 mg/L for lead were below regulatory maximum concentrations.

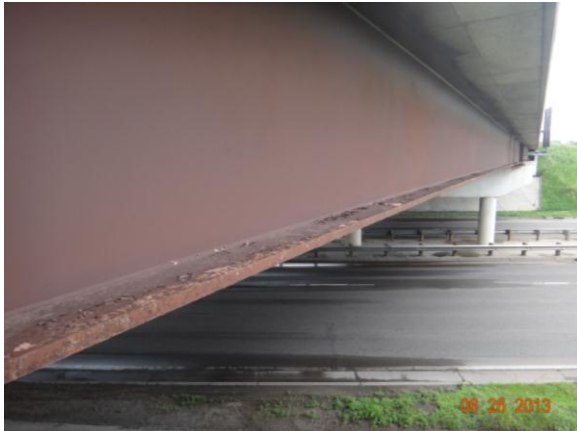
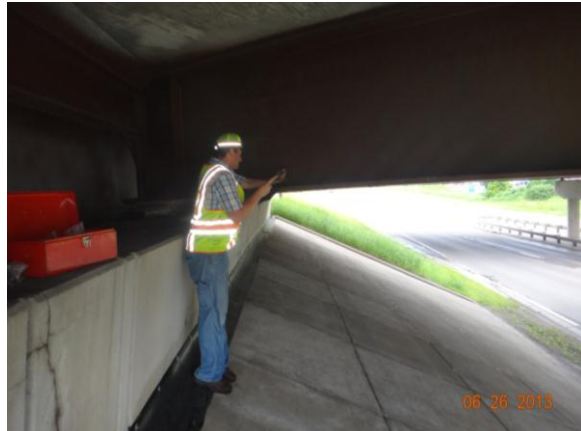
### **Bridge #19038**

*Figure 3.4.55: Bridge #19038 with roadway*

*Figure 3.4.56: Bridge #19038 sampling location*

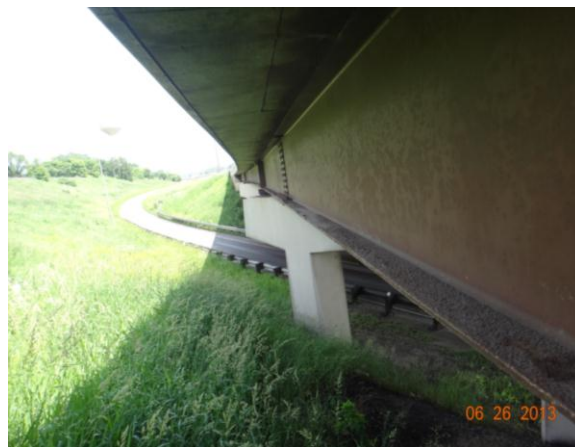
### **Bridge #19884**

*Figure 3.4.57: Bridge #19884 sampling location with roadway*

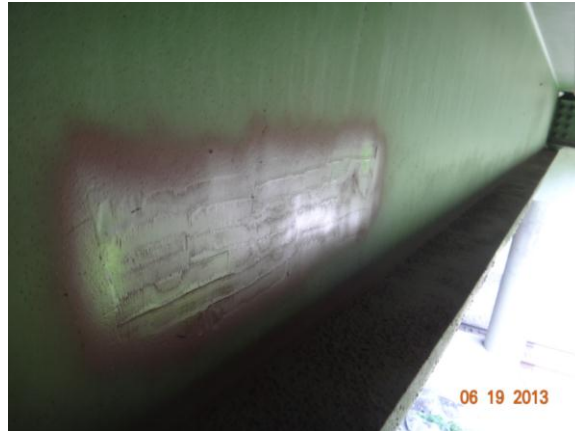
*Figure 3.4.58: Bridge #27513 sampling location with roadway*

No arsenic, chromium, mercury, selenium, or silver was detected for Bridge #27513. The reported level of 0.14 mg/L for barium, 0.15 mg/L for cadmium, and 0.093 mg/L for lead were below regulatory maximum concentrations.

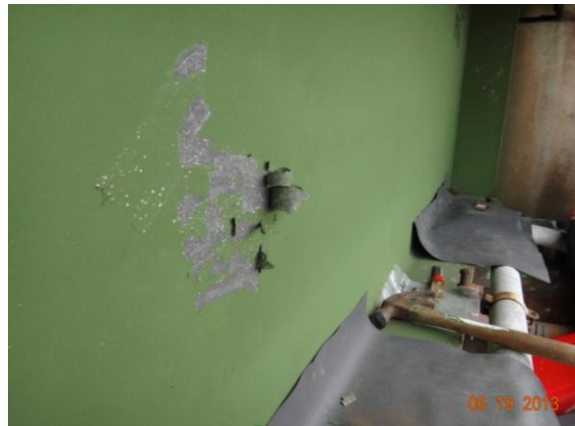
*Figure 3.4.59: Bridge #27517 sampling location*

No arsenic, chromium, mercury, selenium, or silver was detected for Bridge #27517. The reported level of 0.41 mg/L for barium, 0.18 mg/L for cadmium, and 0.25 mg/L for lead were below regulatory maximum concentrations.

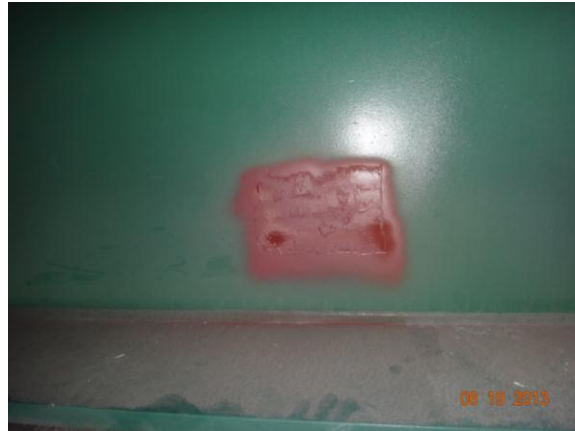
*Figure 3.4.60: Bridge #27106 sampling location*

No arsenic, chromium, lead, mercury, selenium, or silver was detected for Bridge #27106. The reported level of 0.094 mg/L for barium and 0.019 mg/L for cadmium were below regulatory maximum concentrations.

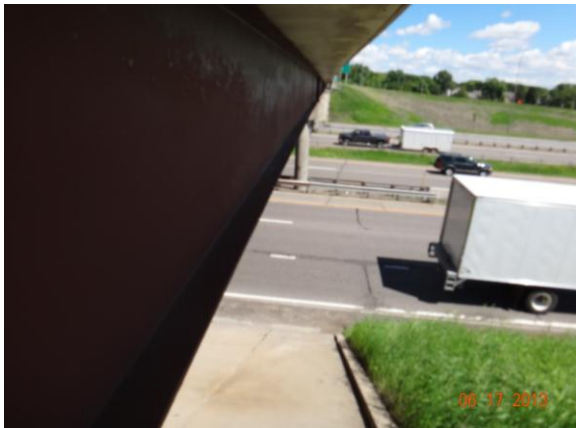
*Figure 3.4.61: Bridge #27080 with roadway*

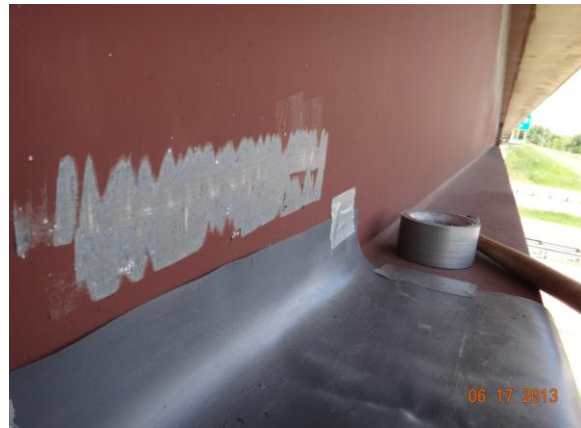
*Figure 3.4.62: Bridge #27080 sampling location*

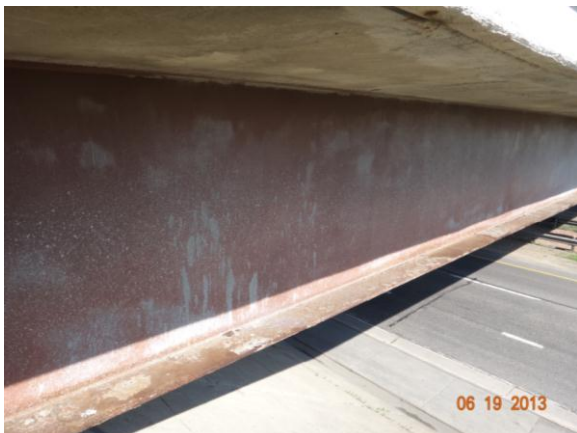
### **Bridge #27014**

*Figure 3.4.63: Bridge #27014 with roadway*

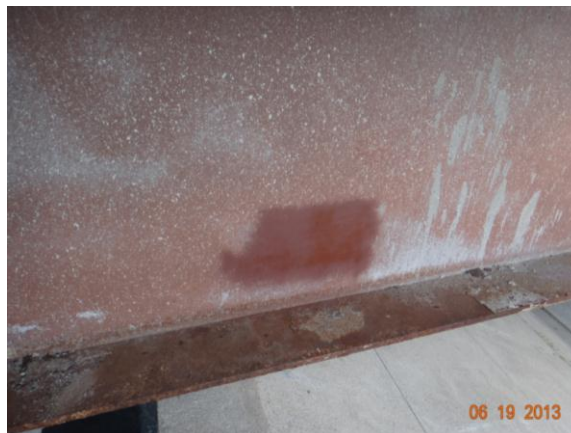
*Figure 3.4.64: Bridge #27014 sampling location*

No arsenic, chromium, mercury, selenium, or silver was detected for Bridge #27014. The reported level of 0.26 mg/L for barium, 0.33 mg/L for cadmium, and 0.33 mg/L for lead were below regulatory maximum concentrations.

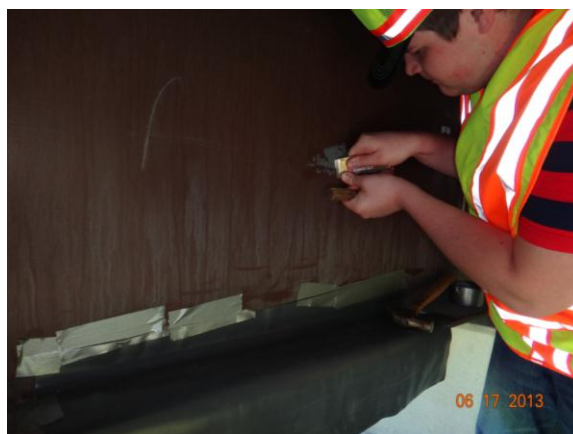
### **Bridge #27573**

*Figure 3.4.65: Bridge #27573 sample location*
