# FINAL STUDY REPORT FOR LOCAL BRIDGE STEEL FATIGUE DETAIL

**COLLINS**  
**ENGINEERS** INC.

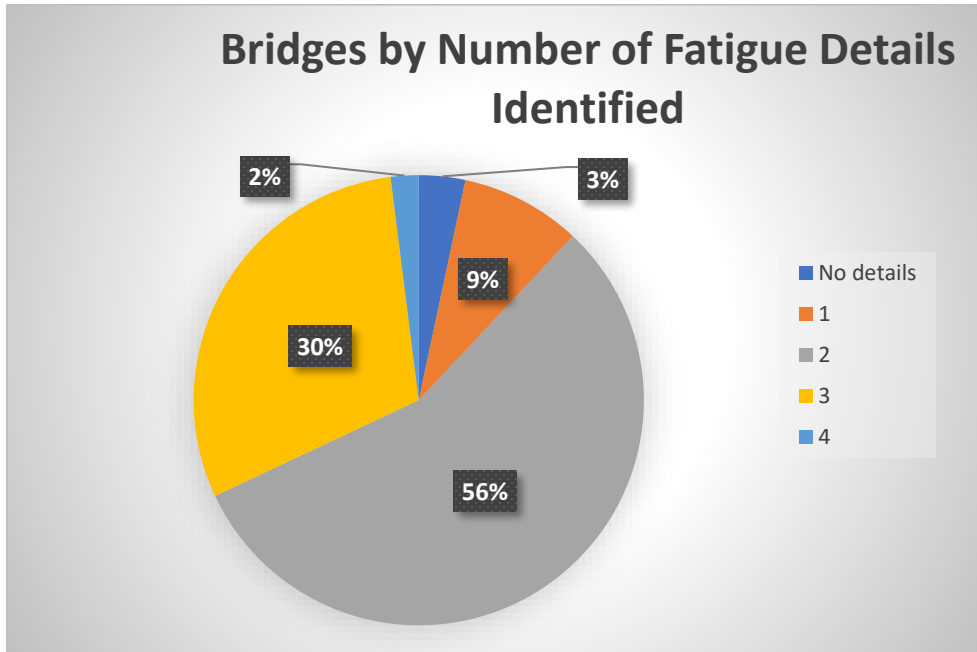
Figure 5: Number of Fatigue Details Identified

Most bridges had 2 different fatigue details. *Figure 5* shows the number of different fatigue details each bridge has.
